# A Numerical Investigation on the Collapse of the Champlain Towers South in Florida

**Abstract**—In this study, the Champlain Towers South building collapse in Florida allegedly caused by a deck collapse was examined through the finite element analysis based on the existing hypotheses and investigation. The Adaptively Shifted Integration (ASI) – Gauss code was applied for the numerical analysis. In addition, the member strength failure algorithm of RC components was modified, and the flat-plate structure was introduced into the numerical model of the building. According to the analyses, the building did not collapse when the pool deck beams connecting to the columns of the 1st-floor interior, so-called key columns, were removed by the collapse of the pool deck. When the model was revised to include deterioration of concrete slab and corrosion of rebars, and then triggered by the removal of columns in the underground parking garage, the middle section of the buildings reached a total collapse. This supports the latest collapse theories, which cite punching shear failure at pool deck columns as the initiating event.

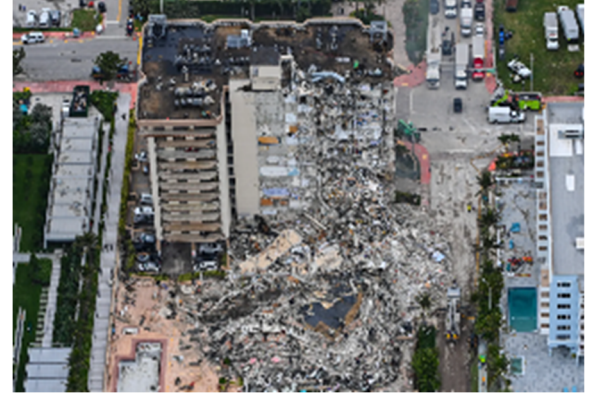
Fig. 3. Collapsed site of the Champlain Towers South.

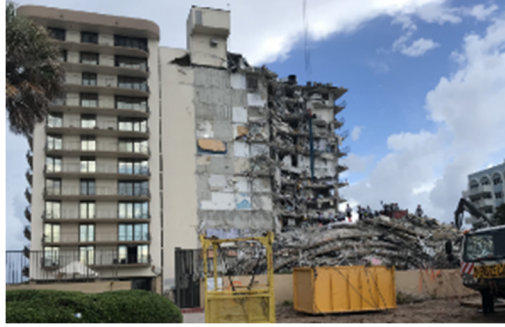
Fig. 8. Western section remaining after the accident.

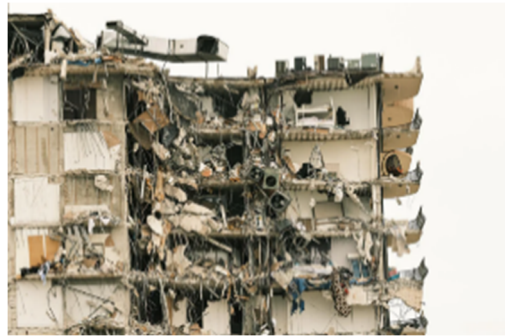
Fig. 9. Enlarged photo of a collapsed section.

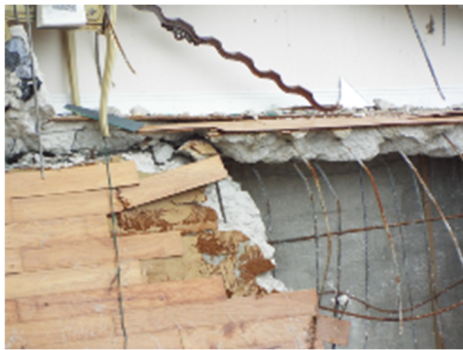
Fig. 10. Cross-section of a collapsed floor.

Since the rebar at both ends of the floor can be seen to be almost cleanly pulled out as shown in Figs. 10 and 11, the critical value of shear strain of the flat-plate floor members from the ground to the 13th floor, shown in yellow in Fig. 14, was set to 1/1000 to account for the pullout of the rebar at the joint between the wind-resistant wall and the flat-plate floor. The weakening of the concrete and reinforcing bars in the subterranean columns was also considered based on the nearly vertical drop of the middle building seen in Fig. 2. According to Sanchez *et al.* [20], after a certain degree of concrete deterioration, the compressive strength reduces about 35% and the modulus of elasticity about 70% at maximum. Therefore, the compressive strength and modulus of elasticity of the concrete in the basement columns were set to 65% and 30% of their original values, respectively, to follow a worst-case scenario. In addition, the tensile yield stress of the steel bars and shear rebars was set to 1/200 of their original values to account for the deterioration of the rebars and poor workmanship. The columns shown in green in Fig. 14 are the columns with lowered bearing capacity. In the analysis, the damage to the subterranean columns caused

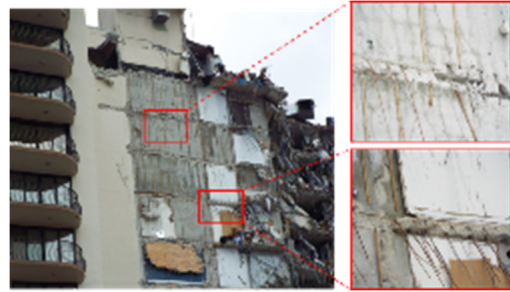
Fig. 11. Wind-resistant wall of western section left at accident site.

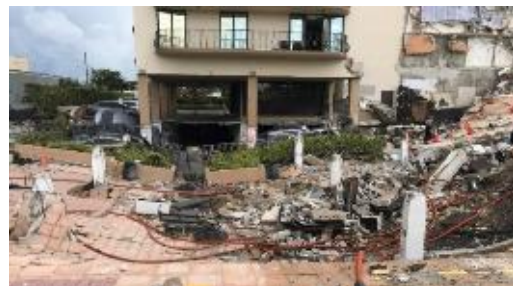
Fig. 12. South end of the uncollapsed western section. This photo is looking west. It can be inferred that the entire pool deck plus two bays of the first level parking slab collapsed in punching shear. The columns of the building did not collapse despite the increased unbraced length. The column labeled for parking space 75 is K-13.1 and the one in front of it is L-13.1. The pool deck collapse is attributed to these two slab-column failures.

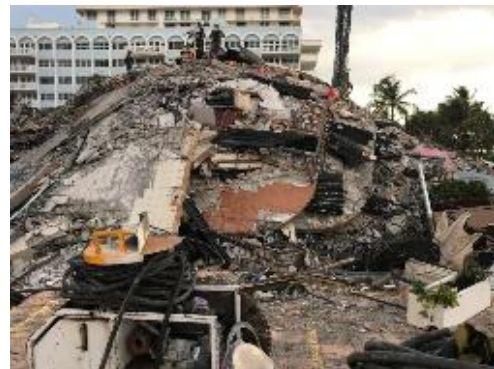
Fig. 13. Slabs of the eastern section. This photo is looking north from the pool deck across the debris pile. The roof is at the left, the tan tile is on the 13th story balcony slab, the red tiles on 12th, and so on, with the pink tile at far right the 9th floor balcony. This indicates the eastern section toppled south and then west.
