## Case Study

# MAINTENANCE AND REPAIRS OF TRAFFIC TUNNELS- A CASE STUDY OF DAREKASA, GONDIA DISTRICT, MAHARASHTRA, INDIA

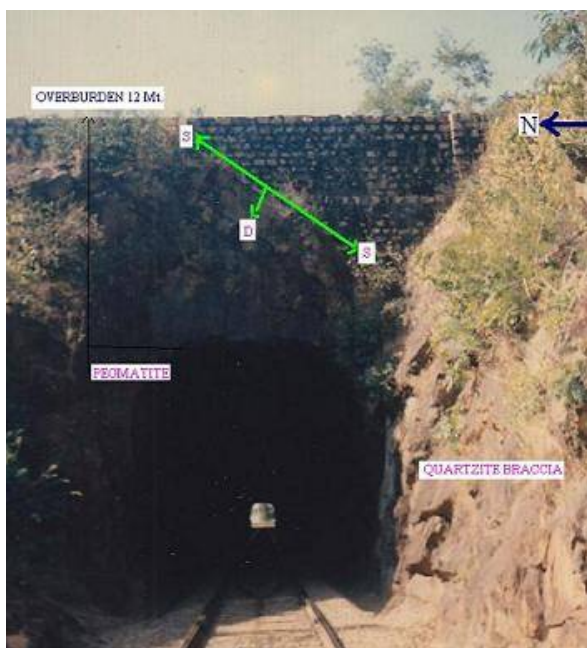
extending up to a level of 22 Mts. or so. In addition, there were small clay pockets observed in roof towards Salekasa end of tunnel as shown in Figure 1. To know the nature and the danger potential of the cracks a close study of the site was made and the following conclusions were drawn. The tunnel rocks consist of Quartzite, Quartzite-Breccias with minor intrusion of Pegmatite. Two types of joints are parallel to strike and other is trending in South-East direction. Minor intrusions of Pegmatite were along strike direction of Quartzite. The Quartzite is pink in color and offer resistance to weathering because of their hard and compact nature. The Pegmatite is coarse grained and also pink in color. The Microcline feldspar in pegmatite is prone to weathering and gives rise to Kaolin clay as shown in Figure 1. The same phenomenon has been noticed in tunnel roof while exposures of hard and compact Pegmatite were seen above the tunnel. The presence of clay pockets is indicative of weathering due to Water and Weathering Damage (WWD).

Numerous joints combining in one alignment have given rise to cracks in tunnel roof. It has been noticed that the cracks diverge from ventilation shafts. The removal of overburden as well as adjoining rocks seem to have resulted into diminishing of pressure, which otherwise was equally distributed in the rocks body. The cracks do not seem to pose any immediate danger to the tunnel roof, but

**Figure 1: Shows Jointed Pegmatite Rocks at Salekase End**

It was noticed that all the joints in the rocks are not open, but some joints have not opened to give rise to cracks few millimeters to few centimeters in width. The widening of cracks is attributed to the abrasive action of water. The cement seems to have applied to fill in the cracks in the roof but this measure was not found to be effective. The enormous pressure exerted by water through interconnecting joints, has loosen the cement and in some places it has been completely washed away. It is thus, obvious that the entry of water through joints and their subsequent widening cannot be prevented by ordinary method of applying cement or by lining of tunnel walls. These will prove preventive measures against collapse only.

In order to achieve everlasting results, the joints in the quartzite should be filled by pressure grouting. The entry of rain water is neither from far away spot on the surface, nor through any master joint, as none was noticed. The joints in the quartzite were so spaced that the pressure grouting is feasible proportion without much loss of cement slurry. Taking advantage of the open joints, on ground

The pockets of clay need different treatment. The clay has a property of absorbing water but not of transmission. The clay pockets even though extending inside the tunnel roof, more than a few meters, do not themselves act as a conductor of water. The clay can however, swell and dislodge from main body by sheer weight. The clay pockets are not weak zones but have potential to pose danger. In order to avoid large quantity of clay as far as possible, and filling the gap by pre-molded cement blocks. Alternatively any suitable material not affected by water can be used.
