Detailed Examination of Myslinka Stone Railway Bridge, Czech Republic

Sarka Nenadalova, Tomas Bittner, Milan Rydval, Lukas Balik, and Milan Hrabanek
Klokner Institute, CTU in Prague, Prague 6, Czech Republic
Email: {sarka.nenadalova, tomas.bittner, milan.rydval, lukas.balik, milan.hrabanek}@cvut.cz

Abstract—A detailed examination of the stone railway bridge Myslinka, built approximately in 1878, was performed. The Bridge is on the railway line Plzeň – Tachov, the Czech Republic. The bridge is created by two parallel vaulted tubes made from sandstone where a frequented road goes through under one of them and Myslinsky brook flows under the second one. In 2006 a reinforced concrete frame structure was inbuilt to the bridge portal. Lengths of the both tubes are about 45.5 m, widths are about 5.7 m, height of the tube above the road is about 6.0 m and the one above the brook is 7.8m. The arch is made as an annular vault. On the basis of the diagnostic works the structure is evaluated from the point of view of moisture, amount of water soluble salts, strengths of sandstone. There is also a visual observation of a condition of the structure itself performed. There are also recommendati

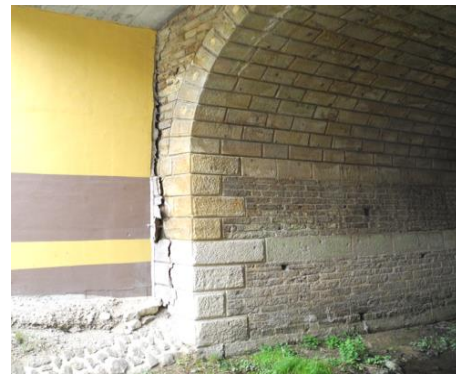
structure made possible to widen the track from one-lane to two-line in the bridge section. This modification unfortunately contributes to a significant damage of the adjoined portal (Fig. 2).

Figure 2. Damaged bridge portal.

concrete frame (oriented to Myslinka village) is significantly damaged (Fig. 2). The cause of the masonry damage is a force action of the unstable reinforced concrete frame. There is an open joint with width of even several tens mm between the stone masonry of the portal and the reinforced concrete frame. Transverse cracks with typical width of 0.3 – 2 mm were detected in the both vaults. According to a visual aspect, an extent of pollution, a rounding of crack edges etc. it is possible to presume that the cracks, apart from exceptions, are very old. These cracks are spreading through stones as well as joints. Mainly thermal or moisture or volumetric changes are the cause of the formation of these cracks. The vaults of the first dilative part (elements of the reinforced concrete frame) are not damaged by cracks, except recently created cracks that are caused by force actions of the unstable reinforced concrete frame. Degradation and falling down of surface layers with thickness 10 – 30 mm was locally observed at particular stones. Especially vertical cracks with typical 0.2–3 mm widths were detected at all supports in locations where the dilative joints of the vaults are not exposed.

The first basic and necessary step is a stabilization of the reinforced concrete frame. During the stabilization it is necessary to carry out such measures to the frame do not be forced active on the bridge stone masonry, it means to the both structures were independent each other and divided by a real dilative joint. It is essential to carry out a proper drainage of the embankment of the frame not to happen water retaining over the vaults of the first dilative parts. It is imperative to perform some insulation against moisture penetration of the reverse sides of the vaults of the first dilative parts. These measures also decrease the possibility of water vapour condensation on the masonry surface because the lower masonry wetness means higher surface temperature of masonry.

Then it is recommended a local replacement of the masonry (damaged pieces of stone) of the portal. Due to the falling down of the surface stone layers discovered in a relatively small extent of the both tubes, in our opinion the repair of these failures is not immediately acute and necessary. For future (in horizon 5–10 years) it is recommended to carry out local repairs not to occur a progressive deterioration of the state [4]. It is advices to the both tubes be washed by pressure water and subsequently repaired joints, mainly by the supports.

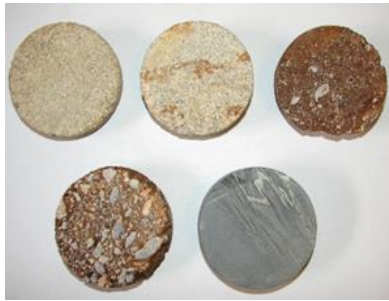
Figure 3. Type of stones taken by core drills

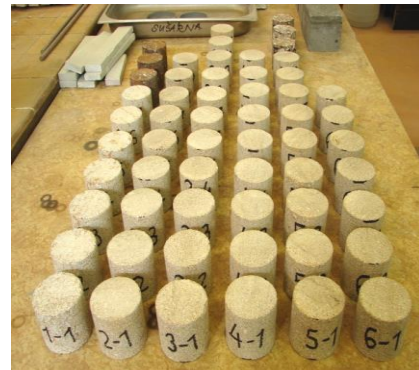
Figure 4. Samples for laboratory tests
