# Experimental Study of RC Frame Infilled with Opening Brick Wall

**Abstract**—A total of three reinforced concrete bare frames infilled with brick walls were cyclically tested in this study. Each frame was infilled with a different shape of brick wall. A cyclically loading test was conducted for each specimen so that the hysteretic behaviors as well as the evolution of the failure mode of each specimen can be revealed, especially for the different shape of the infilled brick wall. In fact, the hysteretic behaviors of each specimen can be disclosed by examining the variations of the hysteretic loops of lateral forces-lateral displacement relationships while the evolution of the failure mode of each specimen can be manifested from the test procedure. There was no short column failure of the side column for each specimen although it was constrained by the infilled brick wall. It is affirmed that the stair-step crack pattern is generally consistent with the diagonal force transfer mechanism of brick walls.

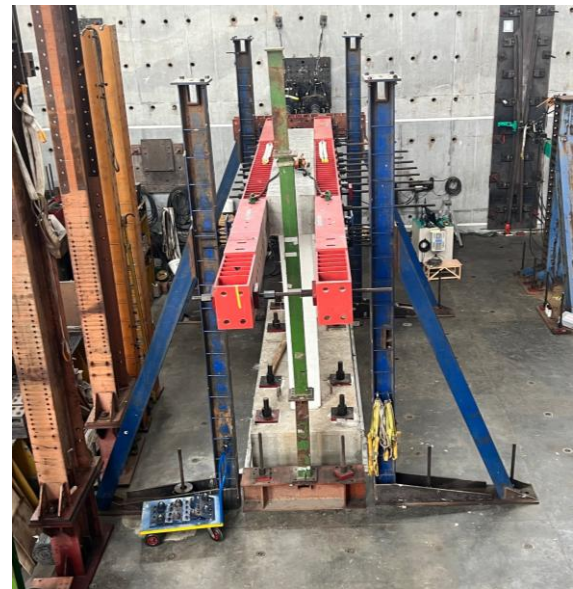
Figure 3. Test setup.

As is shown in Fig. 3, a fabricated reinforced concrete frame infilled with brick walls was fixed into a strong steel frame by connecting its foundation to a strong floor. Two hydraulic actuators were installed at the both sides of the frame for lateral loading of the frame at the beam's mid-height. Besides, two load cells were used to measure the applied lateral loads to the steel frames and the lateral displacement of the steel frame was measured by a Linear Variable Differential Transformer (LVDT) at the mid-height of the top beam of the steel frame [13, 14]. Each specimen was subjected to a quasi-static cyclically loading that was recommended by FEMA 461 [15]. The loading sequence as shown in Fig. 4 is composed of a

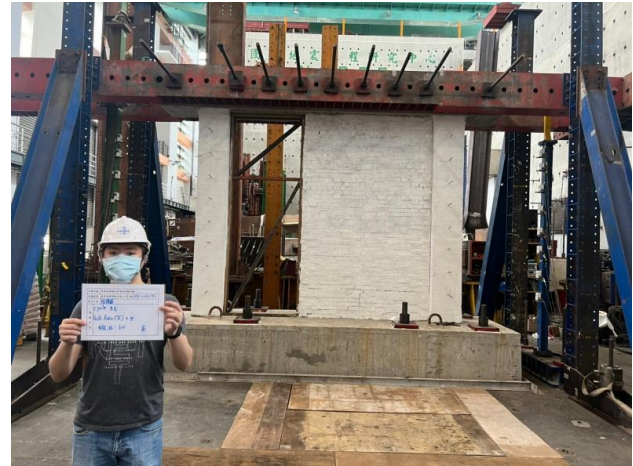
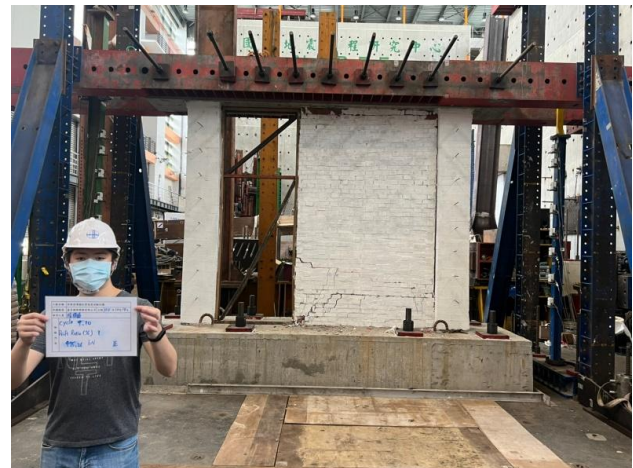
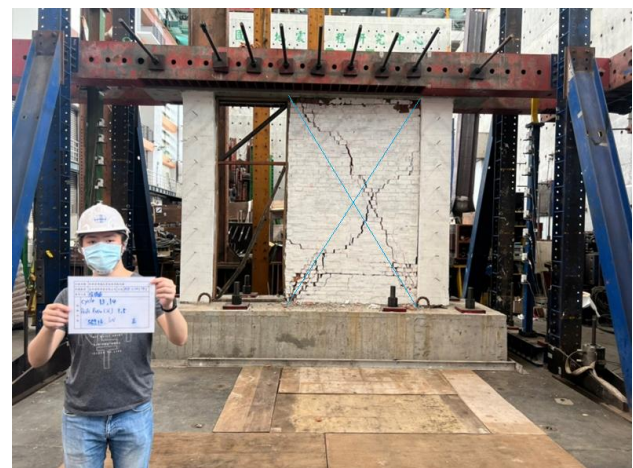
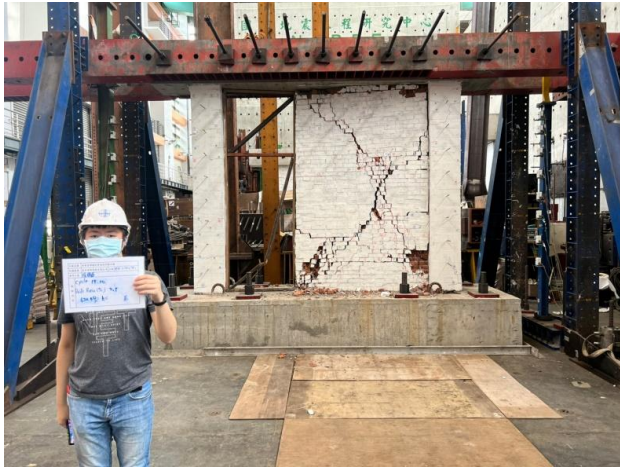
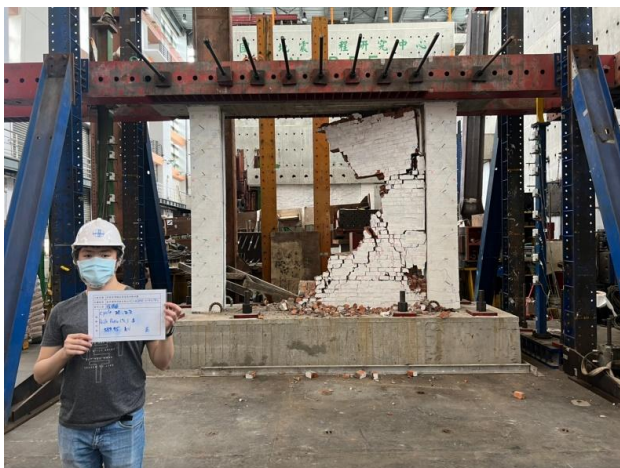
The development of crack pattern of S1 is shown in Fig. 5. Only very small horizontal flexural tensile cracks appeared at the top of columns at the inter-story drift ratio of 0.25%. Notice that there was no crack in the brick wall at this inter-story drift ratio. As the inter-story drift ratio reached 0.50%, an inclined crack was initiated at the left-bottom corner of the brick wall and it propagated upward and rightward gradually to about half-width of the brick wall. Subsequently, this crack became a bed-joint sliding opening when it propagated to the right brick wall. At the inter-story drift ratio of 1.00%, the width of the first crack increased significantly. Besides, a new inclined crack was found right above the first crack. Evidently, two diagonal cracks of the brick wall were formed and intersected at the center of the brick wall as the inter-story drift ratio of 1.50% was reached. Therefore, the diagonal force transfer mechanism was clearly established. Some splitting cracks and crushed bricks were found around the four corners of the brick wall.

As the lateral displacement increased, multiple inclined diagonal cracks of the brick wall were found. In addition, more splitting cracks and crushed bricks were visible near the four corners of the brick wall, as the inter-story drift ratio of 2.50% was imposed. In this drift ratio, the infilled brick wall reached its maximum lateral strength. After the maximum lateral strength was achieved, cracks continued to grow and expand along the main path of the stair-step cracking, and new cracks were also developed in intact sections of the brick wall until a large quantity of bricks were crushed and disintegrated as the inter-story drift

ratio of 3.00% was reached. As a result, the brick wall was collapsed as shown in Fig. 5(e).

It is manifested from Fig. 5(c) that the mechanism of diagonal force transfer was clearly formatted in the brick wall. Hence, it seems appropriate to adopt a compressive bracing to mimic an infilled brick wall under compressive loading as indicated in Fig. 5(c).

Figure 5. Development of crack pattern of S1.

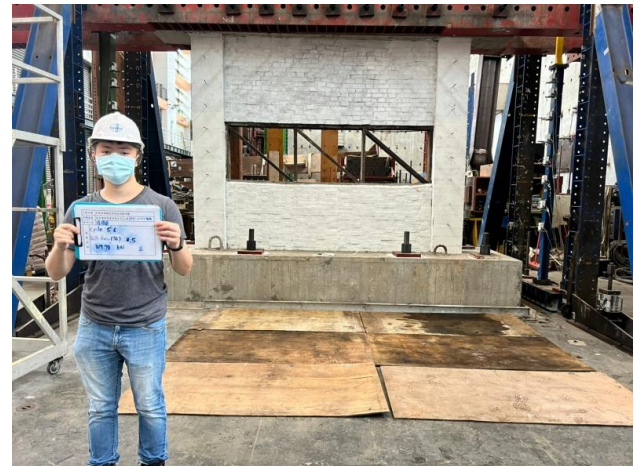
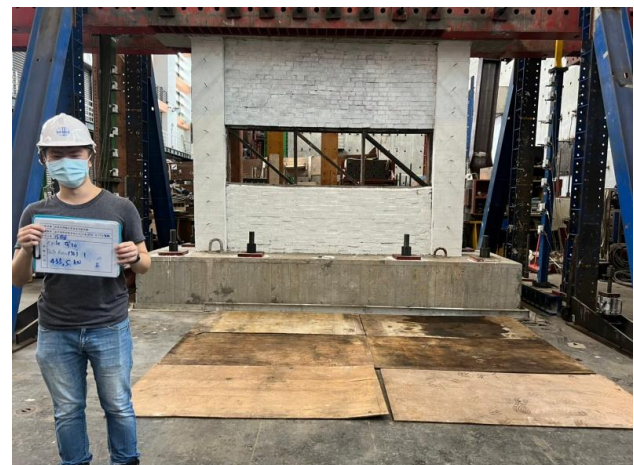
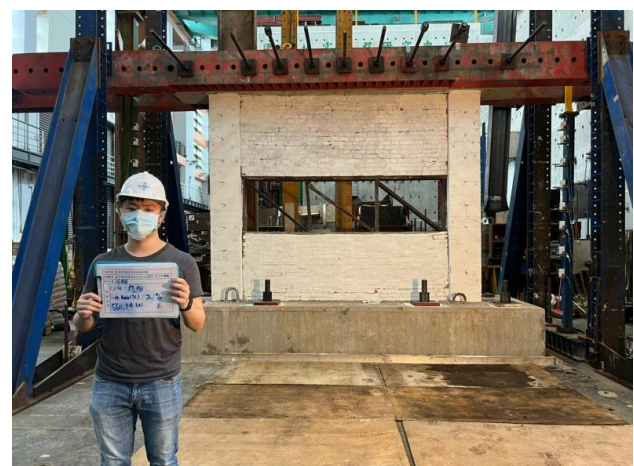
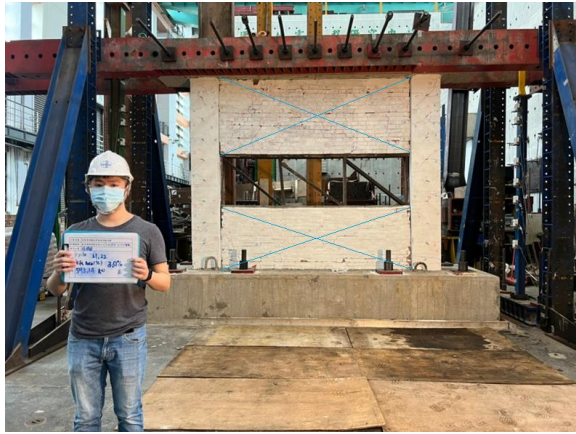
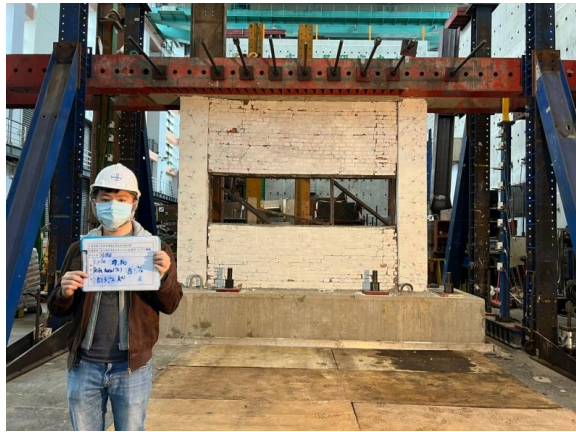
Fig. 6. shows the development of crack pattern of S2. It is seen that there was almost no crack in the brick wall before the inter-story drift ratio of 0.50%. An inclined stair-step crack was initiated from the left-bottom corner of the top brick wall and then it propagated upward and rightward to the bottom of the beam as the inter-story drift ratio was 0.50%. A new inclined stair-step crack was found and almost parallel to the first inclined stair-step crack at the inter-story drift ratio of 0.75%. Both inclined stair-step cracks continued to growth and more splitting cracks occurred in the central area of the top brick wall as inter-story drift ratio reached 1.00% as shown in Fig. 5(b).

At the inter-story drift ratio of 2.00%, splitting cracks continued to grow in the top brick wall and an inclined stair-step crack was initiated from the left-bottom corner and it propagated rightward and upward gradually. It is seen in Fig. 5(d) for the inter-story drift ratio of 3.00%, the width of the two inclined stair-step crack increased and vertical cracks were also found in the right part of the top brick wall. A new inclined stair-step crack was found in the bottom brick wall. The maximum lateral strength of S2 was reached at this drift ratio. At the inter-story

drift ratio of 5.00%, some bricks near to each side column for both top and bottom brick walls were crushed.

It is evident that the top brick wall experienced more severe damage in contrast to the bottom brick wall. It is also found that the crack pattern of the top brick wall is also different from that of the bottom brick wall. It seems that either top or bottom brick wall can be simulated by two diagonal bracings as shown in Fig. 5(c).

Figure 6. Development of crack pattern of S2.

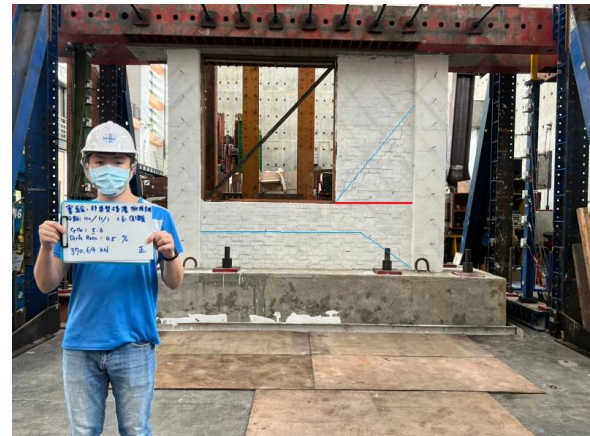
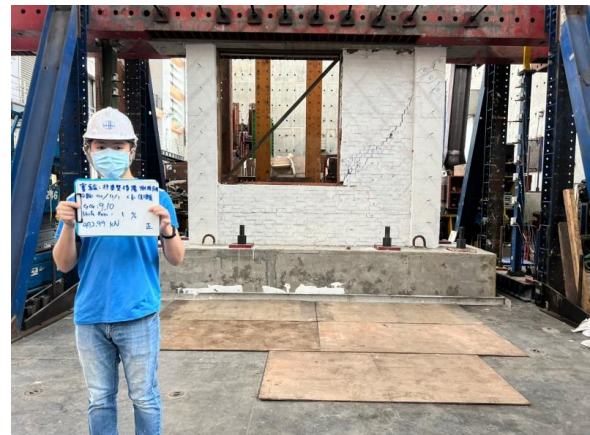
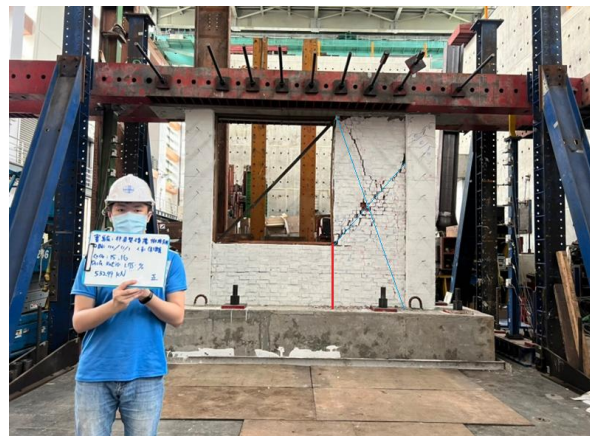
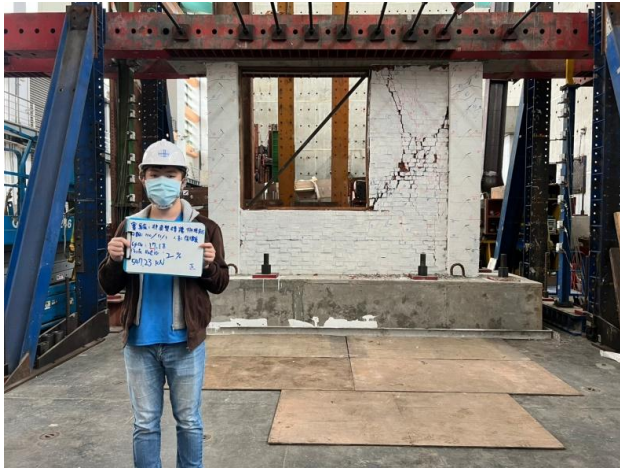
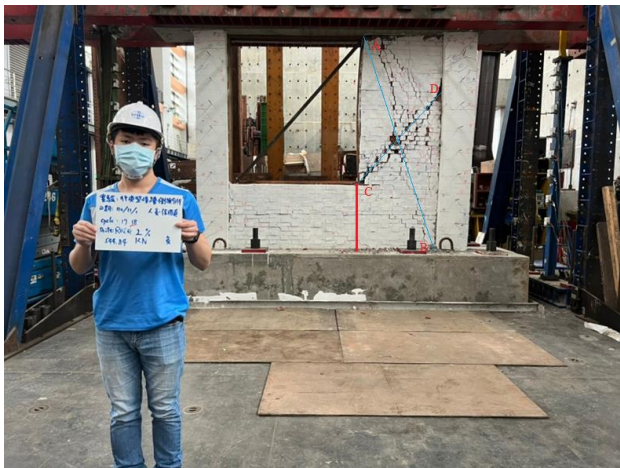
Both the development of crack pattern and evolution of failure of S3 are plotted in Fig. 7. For the convenience of the subsequent discussions of S3, the L-shape brick wall is divided into a top brick wall and a bottom brick wall by a red line as shown in Fig. 7(a). At the inter-story drift ratio of 0.50%, there was an inclined stair-step crack from the left-bottom to right-top of the top brick wall. Besides, a horizontal crack was discovered in the mid-height of the bottom brick wall and it propagated to the right-bottom of the brick wall as shown in Fig. 7(a). At the inter-story drift ratio of 1.00%, the inclined stair-step crack grew and expanded. Some splitting cracks were found in the left-bottom of the top brick wall in addition to some crushed bricks. It is evident that the mechanism of the diagonal force transfer was formatted for the top brick wall. The stair-step cracking in the bottom brick wall also became more significant.

In Fig. 7(c), the cracking pattern implies that it seems more appropriate to divide the L-shape brick wall into two small brick walls by a vertical red line as shown in this plot. Hence, one can find that a new inclined stair-step crack started to gradually propagate from the left-top to the right-bottom of the top brick wall at the inter-story drift ratio of 1.50%. More splitting cracks and crushed bricks was also found around the central area of the right brick wall. In Fig. 7(e), at the inter-story drift ratio of

2.50%, an inclined stair-step crack was clearly formatted from the left-top to right-bottom of the right brick wall while another inclined stair-step crack was formatted in the middle part of the right brick wall and started from its left-bottom to right-top. Thus, it seems that the diagonal force transfer mechanism can be used to model both stair-step cracking curves. In fact, a compressive bracing of AB can be used to represent the diagonal force transfer mechanism as a lateral force is loaded in a direction from left to right while a compressive bracing of CD can be used to denote the diagonal force transfer mechanism as a lateral force is imposed upon S3 in a direction from right to left.

Figure 7. Development of crack pattern of S3.

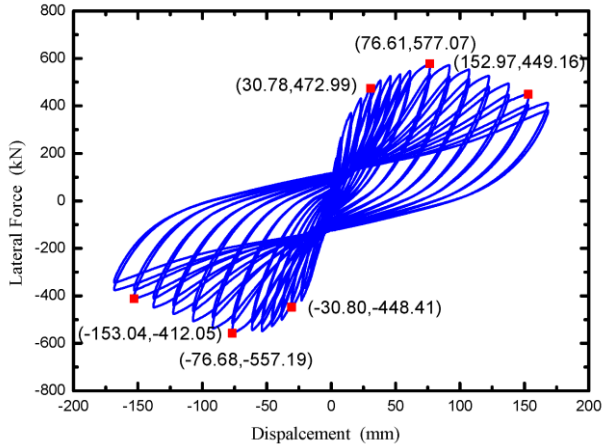
An average yielding displacement of  $\delta_y = 30.79$  mm is found for S3 in Fig. 10 and an average corresponding lateral yielding force is 460.70 kN. It is also revealed by

this figure that the average maximum lateral force is 567.13 kN and an average ultimate lateral force of 430.61 kN is identified. Thus, an average corresponding ultimate displacement is found to be  $\delta_u = 153.01$  mm. As a result, one can have the ductility of  $\delta_u / \delta_y = 4.97$ .

Figure 10. Force-displacement hysteretic loops for S3.

After conducting the cyclically loading testing of S1, S2 and S3, the hysteretic loops of the force-displacement relation for each specimen are plotted in Figs. 8–10 for S1, S2 and S3, respectively. In this work, the lateral force is the total force applied by the two actuators and the lateral displacement the specimen is an average value of the values measured from the two LVDTs. Besides, in each figure, the yielding point, maximum lateral force point and ultimate lateral force point were marked, where the ultimate lateral force was taken to be the 80% of the maximum lateral force [16–22]. In this study, an average value is generally calculated from the two values in the push and pull directions, such as  $\delta_y = (\delta_y^+ + \delta_y^-) / 2$ . In addition, as can be seen in Figs. 8 to 10, the major resistant brick wall of each specimen was destroyed while the two side columns can still remain stable at the end of the test. It seems that the yielding point as shown in Figs. 8–10 for S1 to S3 generally occurred as the major resistant brick wall was severely destroyed for each specimen.
