Research Paper

EXPERIMENTAL STUDY OF MASONRY VAULTS REINFORCED WITH COMPOSITE MATERIALS

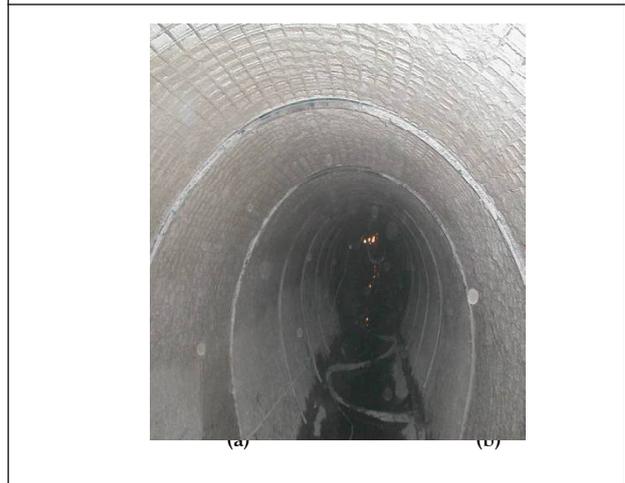
Figure 3: Construction Reinforced with Shotcrete [4]

shotcrete lining of 6 to 8 cm in thickness on an entire section of the drain (Figure 3) or using rigid or flexible prefabricated elements to fill the annular space.

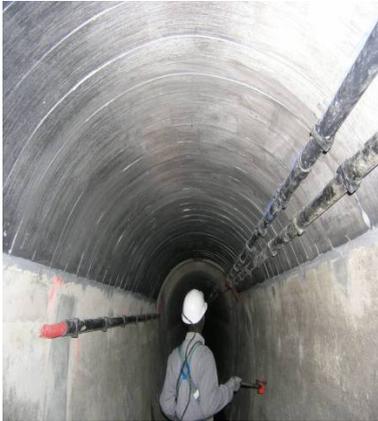
Figure 4: Construction Reinforced With Composites MatériaIs [6]

Following advances made in the construction industry and public works, Kesteloot (2006) carried out a study on the reinforcement of concrete ovoids reinforced with the aid of composite materials. A load gain of 50% was noted in comparison with ovoids with nonreinforced concrete. The results of this study demonstrated the adaptability and advantages offered by the application of this new procedure to accessible, ovoid reinforced concrete drains. This procedure was applied at a site in Saint Maur (94) in France in 2005. Since this procedure was employed, no deterioration has been observed (see Figure 4).

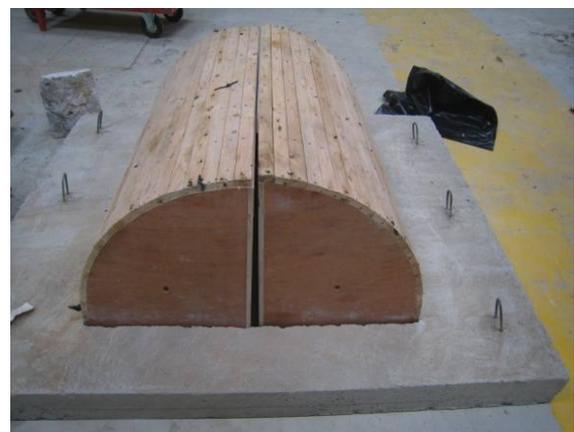
Figure 11: Wooden Formwork

Wooden half-cylinder form works were designed (see Figure 11). The height of the arches was 55 cm. The arches were made up

of two juxtaposed parts, with each corresponding to a half-vault. This arrangement facilitated the removal of the formwork after construction was completed. Millstone blocks of various shapes were arranged on the arches to create a mesh. The blocks were cut and trimmed by stonecutting specialists. The vaults were subsequently hand-built, as shown in Figure 12.

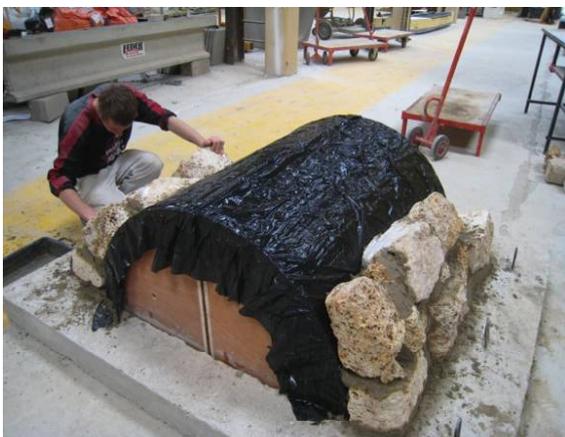
Figure 12: Construction of the Vaults

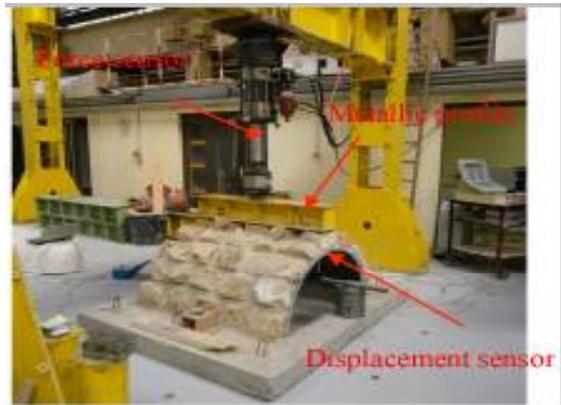
Figure 13: Experimental Device

The trials were performed with a single vertical loading on the vault. The horizontal resultant for soil movement was not taken into account to highlight the zone that was the most stressed, that is, the keystone with respect to the tensile stress present in the keystone. This loading is thus the least favorable loading. To obtain a load that is uniformly distributed on the upper part of the keystone, a metallic profile (0.20 m x 1.20 m) was placed on the keystone. Load application was performed uniformly without slippage on the keystone. The actuator has a capacity of 250 kN. The test setup was directed remotely at a speed of 0.01 mm/s. During the trials, instrumentation included a displacement sensor and a force sensor to measure the load. An inductive displacement sensor was located at the level of the keystone on the intrados (i.e., vertical displacement). The range was 100 mm (see Figure 13).

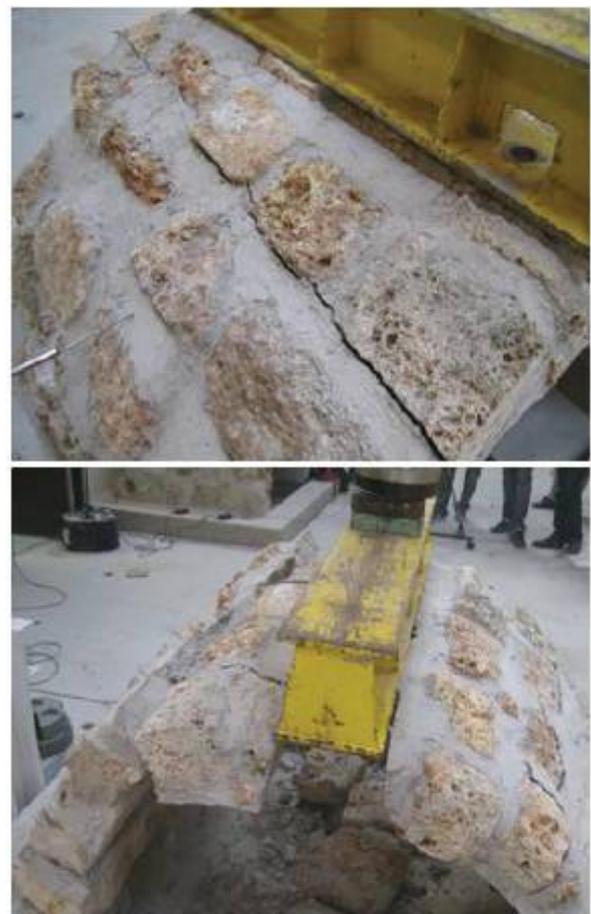
Figure 15: Cracks in the Mortar Joints at the Level of the Spandrels on the Extrados

curve, we can distinguish two phases. In the first phase, load values did not lead to significant cracking in either the binding mortar or in the millstone. The first crack appeared in the mortar joints at the level of the spandrels on the extrados and subsequently at the keystone on the intrados for a load of 7 kN. In the second phase of the trial, the load values produced cracking in the binding mortar across the entire length of the vault. The breaking load was 9.32 kN for a displacement of 0.77 mm. The cracks appeared in the same way for the two vaults (Figure 15).

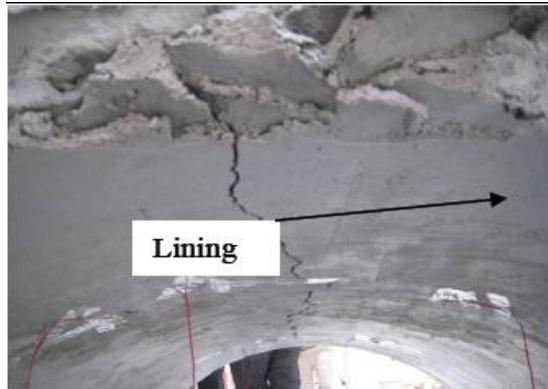
Figure 17: Cracking at the Keystone Of the Vault Lined On The Intrados

The behavior of the vault exhibits two phases, as with the control vault. The breaking load for the reinforced vault was 18 kN. The displacement of the vault was 1.3 mm. This displacement corresponds to a gain of approximately 114% for the load at first crack and 93% for the breaking load. The addition of a lining helped increase the breaking load. Meanwhile, the first crack appeared at the keystone on the intrados at 15 kN (i.e., the first phase of the curve). Next, cracks appeared at the level of the spandrels on the extrados and were propagated in the joints of the masonry across the entire length of the vault until breakage occurred on a single side (see Figures 17 and 18).

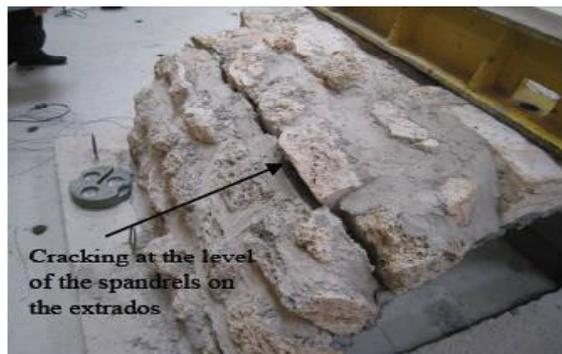
Figure 18: Cracking In The Mortar Joints at the Level Of The Spandrels On The Extrados

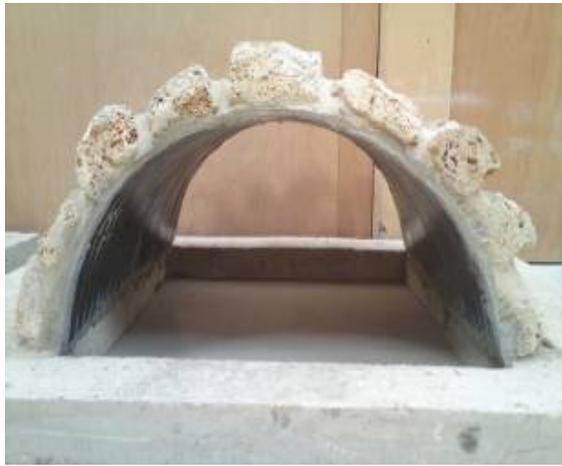
Figure 19: Lined Vault Reinforced by Carbon Strips

The addition of the carbon-fibre strip was achieved by double gluing. A fine layer of adhesive was applied on the support and on the strip (Figure 19). This double gluing allows for uniform dispersion of the adhesive. Then, the surplus adhesive was scraped with a roller.

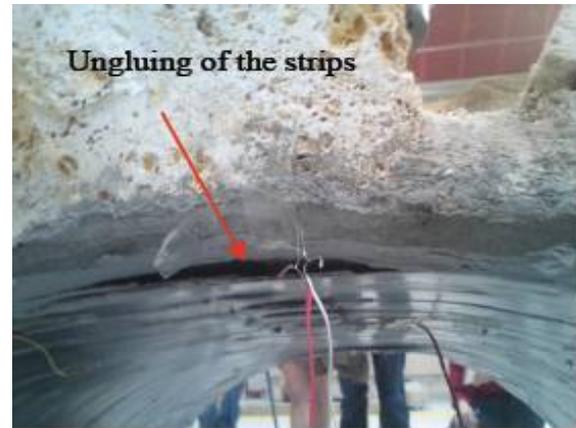
Figure 21: Strip Ungluing

appeared both in the mortar joints at the level of the spandrels on the extrados and in the middle of the abutments on the extrados (Figures 20-22). After the breaking load of 85.85 kN, the load diminishes rapidly as the strips at the keystone on the intrados became unglued (Figure 21). The tensile strength gain is about 788% that of the unlined vault and approximately 377% that of the lined vault. The vault behavior exhibited an elastic zone followed by fragile failure.

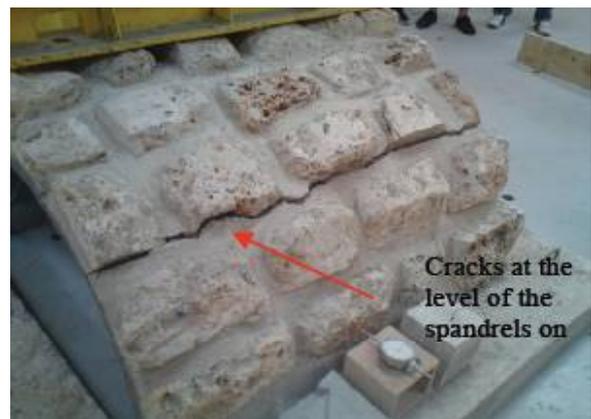
Figure 22: Cracks at the Level of the Spandrels on the Extrados

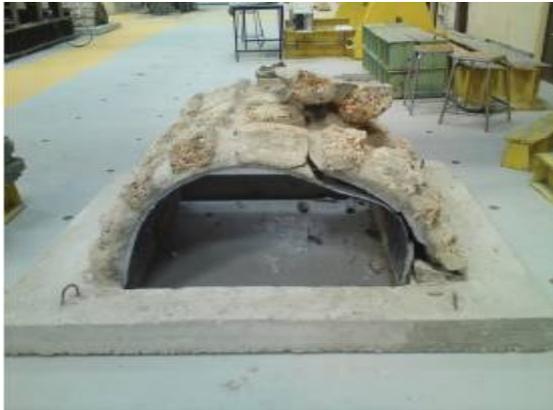
Figure 23: Vault Reinforced with Carbon-fibre Strips

The cracks were continuous across the entire length of the vault. The vaults reinforced by strips did not undergo sagging (see Figure 23).

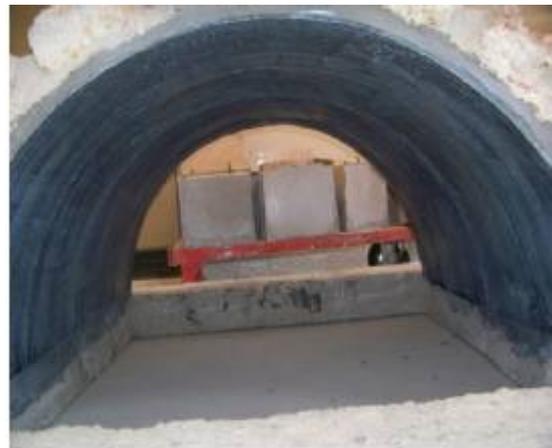
Figure 24: Lined Vault Reinforced With Carbonfibre Fabric

layer of adhesive was applied on the support. Next, the fabric was arranged on the intrados of the vaults with the assistance of a PVC spatula. As with the strips, a roller was used to remove any surplus adhesive (see Figure 24).

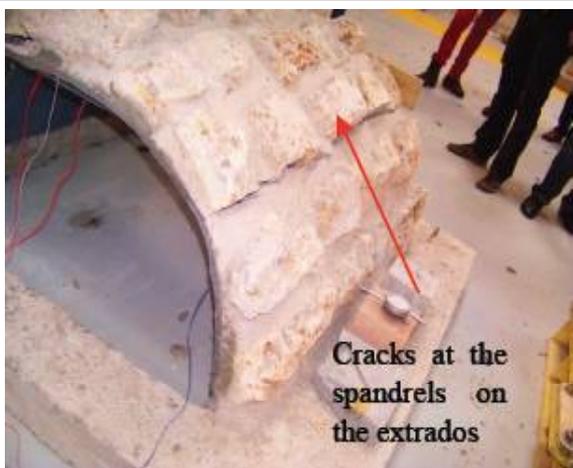
Figure 27: Cracks at the Spandrels on the Extrados

fabric. The tensile strength gain was approximately 600% that of the unlined vault and 276% that of the lined vault. In contrast, the tensile strength gain was reduced by 21% compared to the vault reinforced with carbon-fibre strips. The failure mechanism is identical for the two vaults tested. Cracks appeared in the mortar joints at the level of the spandrels on a single side (see Figure 27).

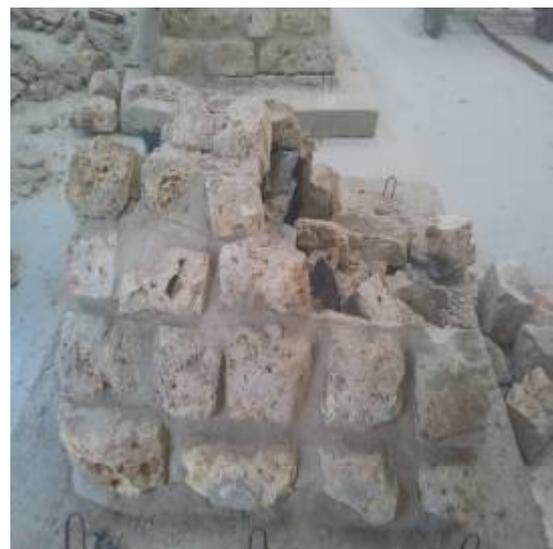
Figure 28: Collapse of a Vault Reinforced by Carbon-fibre Fabric

The cracks are continuous across the entire length of the vault. The vaults reinforced by carbon-fibre fabric collapsed (see Figure 28).

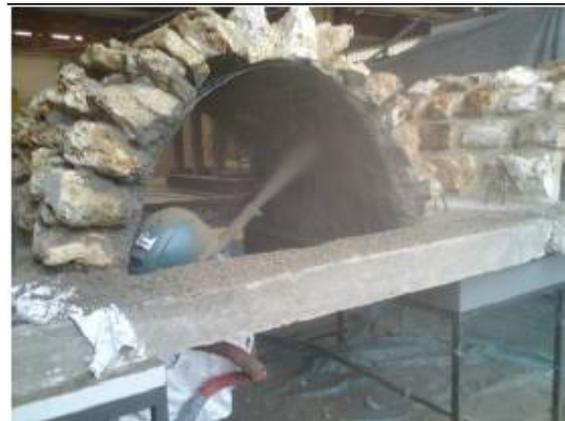
Figure 30: Spraying of Shotcrete

Measurements of shotcrete resistance (see Figure 30) were obtained by carrying out compression trials (see Figure 32) on previously cored 6 x 12 cm² samples of sprayed shotcrete (Figure 31). The average resistance was 36.7 MPa (Table 8).

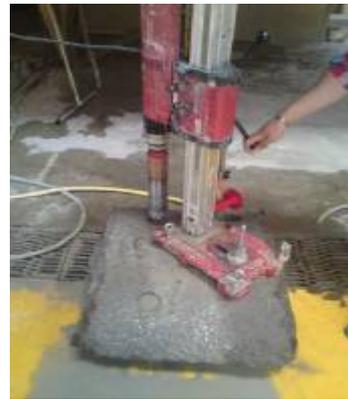
Figure 31: Coring of the 6 x 12 cm² Samples

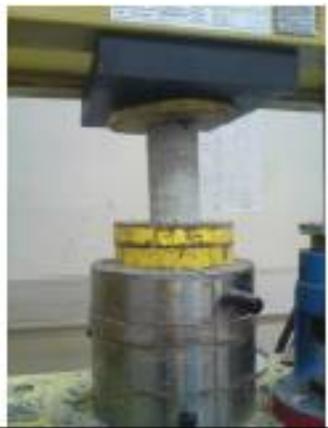
Figure 32: Compression Trial

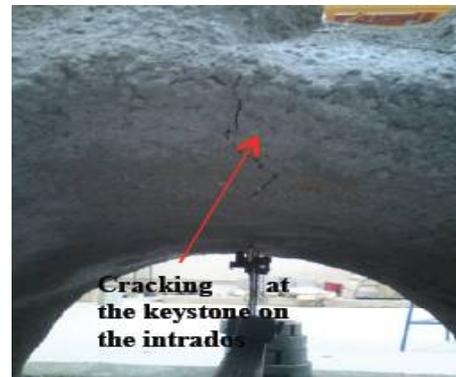
Figure 34: Breaking Mechanism

The curve shows three zones. An elastic zone is followed by a plateau up to 125 kN, which corresponds to a deflection of 1 mm. Beginning with a displacement of 1.25 mm, the behavior of the vault reinforced with shotcrete is elastic. The breaking load is 162.66 kN with a displacement of 2.25 mm. The first crack appeared at the keystone on the intrados at 110 kN (Figure 34) and continued until failure.
