# Development and Implementation of Precast Paving Notch System for Accelerated Bridge Repair

**Abstract**—Differential approach pavement settlement and the resulting formation of ‘bumps’ at the end of the bridge is a recurring problem for many State highway agencies. One of the main contributing factors in this settlement is deterioration or failure of the bridge paving notch. The conventional replacement procedure typically involves construction of a time-consuming, cast-in-place concrete paving notch followed by replacement of approach slab pavement. The objectives of this work were to develop a new, precast paving notch system and to verify and evaluate the structural capacity and implementation feasibility. The goal with rapid replacement would be a bridge approach slab support that can be installed in single-lane-widths to allow for staged construction under traffic during a single overnight closure. This paper presents a summary of the laboratory testing and field implementation of the precast paving notch system.

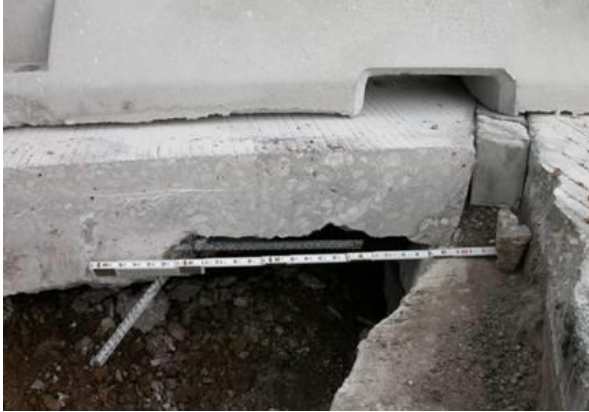
Figure 1. Paving notch failure/deterioration.

[2] One of the main contributing factors in this settlement is deterioration or failure of the bridge paving notch. A paving notch (also known as a corbel or a paving support) consists of a horizontal shelf constructed on the rear of a bridge abutment and is used to support the adjacent roadway pavement. [3] These paving notches have been observed to deteriorate/fail due to a number of complex factors including horizontal abutment movement due to seasonal temperature changes, loss of backfill materials by erosion, inadequate construction practices, foundation soil settlement, heavy traffic loads, salt brine that leaks through the expansion joint, and open expansion joints that fill with dirt and debris and ‘push’ the approach pavement off the paving notch. In some cases, the condition of the paving notch deterioration may not be noticed until the deterioration reaches a critical state and the approach pavement is removed (Fig. 1).

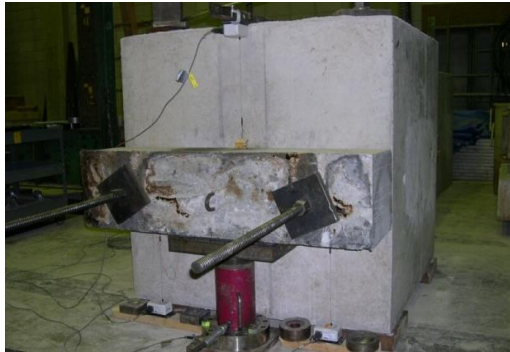
Figure 4. Assembled precast paving notch system (Phase 1).

The first phase of testing was intended to investigate the post-tensioning (PT) force needed to prevent slip of the paving notch system (i.e., friction force between the abutment and the paving notch specimen) without using an adhesive. [7] Assembly of the paving notch system involved attaching the paving notch specimen to the abutment block with 1 in. diameter Dywidag threaded bars—127.5-kip ultimate strength capacity – spaced at 3 ft on center. After attachment, the paving notch system was post-tensioned using a compact lightweight hydraulic jack containing a socket wrench and ratchet device that allows the nut to be tightened as the bar elongates. The paving notch system was instrumented with three displacement transducers: one transducer on top surface of the paving notch specimen directly above the load point and two transducers on the bottom surface of the paving notch specimen directly below the Dywidag threaded bars. A sample photograph of the assembled precast paving notch system instrumented with displacement transducers is presented in Fig. 4.

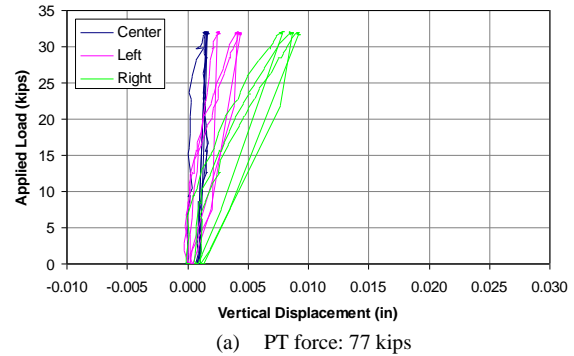
(a) PT force: 77 kips

(b) PT force: 51 kips

(c) PT force: 26 kips

Figure 5. Load-slip test results for Phase 1.

slowly released to zero and the loading sequence repeated three times. A total of six static load tests were conducted with each test completed in a similar manner with the exception of the PT force applied to the system. The next static load test involved the specimen with 10% less PT force applied to the system (i.e., approximately 50% of the ultimate strength of the bars). The static load test was repeated until the PT force was down to 13 kips (i.e., approximately 10% of the ultimate strength of the bars). The load-slip measurements were made for each static load test and sample plots are presented in Fig. 5.

Before testing, it was expected that, when there was adequate frictional resistance, any displacement induced by an applied load would return to zero when the load was removed. This was confirmed by the first static load testing where virtually no residual displacement (slip) occurred when the specimen was attached to the abutment with 77 kips of force. The first indication of slippage was observed at 26 kips of PT force and the slippage continued to increase as the PT force was further reduced. The testing was stopped at 13 kips of PT force as the manifestation of residual displacement (slip) was obvious.

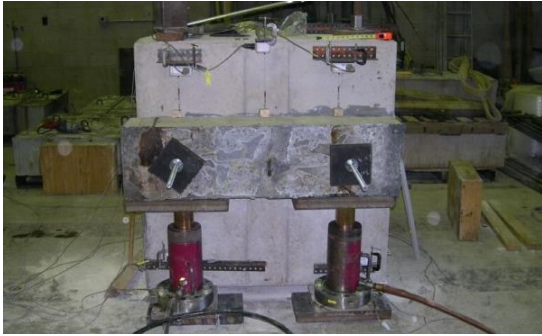
Figure 6. Assembled precast paving notch system (Phase 2).

of the specimen. The specimen was then loaded with two hydraulic jacks placed directly below the stainless steel bars as shown in Fig. 6. The same basic loading procedure used in Phase 1 was used except, in this test, the zero-to-32-kip load cycle (16 kips for each jack) was repeated four times. After the four service-level cycles, the specimen was loaded to failure. Presented in Fig. 7 are the results of this testing. As shown, virtually no slip was observed during the four cyclic loadings and the precast paving notch system failed at approximately 62 kips.

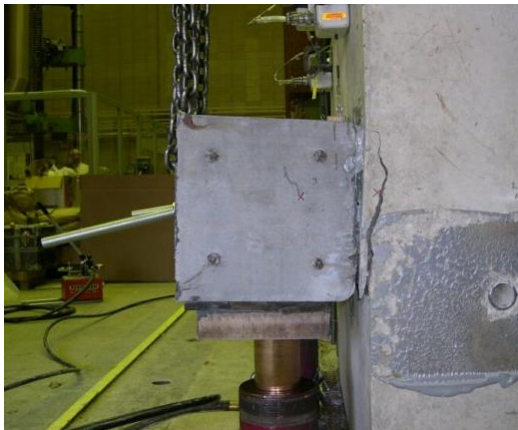
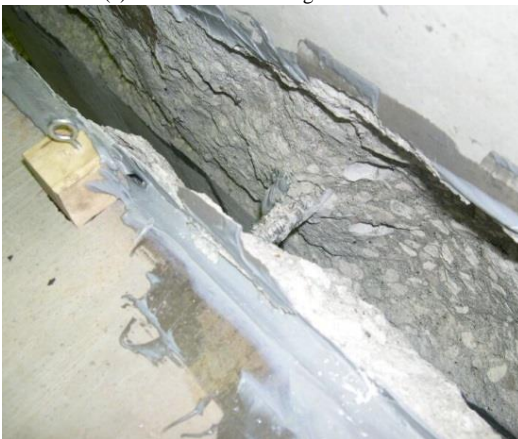
(a) Side view showing cracked abutment

(b) Failed abutment concrete

Figure 8. Post-test inspection illustrating typical cracking failure.

After the test was completed, the connection was visually inspected. Fig. 8 shows a crack in the abutment concrete that seemed to propagate upward near the connection. It appeared that the failure during Phase 2 testing was a result of a combination of shear and outward prying. It was speculated that this phenomenon was due to the vertical force being applied slightly eccentrically, which caused bending stresses at the interface surface. In attempt to further improve the performance, an additional row of stainless steel bars (i.e., one set of bars close to the top and one set close to the bottom) was added to enhance system resistance to

After removing the precast paving notch from the abutment (Fig. 8), it was observed that there was an obvious indication that the failure occurred primarily in the abutment concrete. This finding indicated that the strength of the epoxy adhesives was adequate.

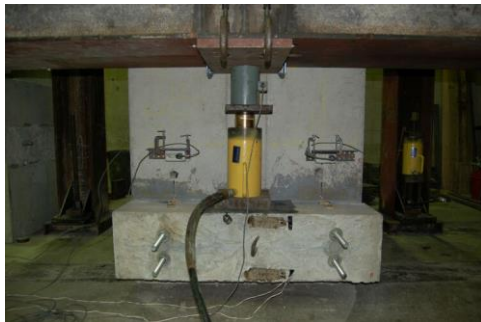
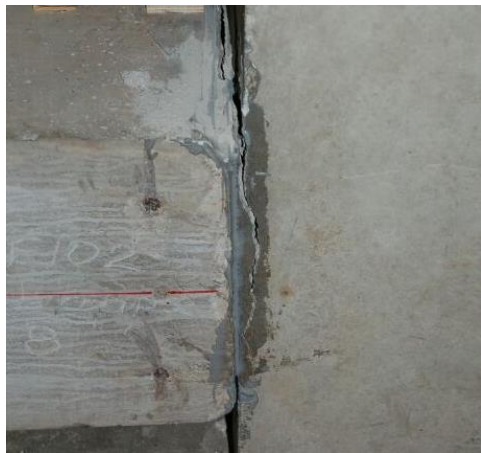
(a) Load test setup

(b) Side view of the failed interface

Figure 10. Photographs of ultimate load test setup and post-test inspection on the specimen with four stainless bars (two rows).

Following successful completion of the cyclic load testing, the precast paving notch system specimen was loaded to failure to obtain a measure of the ultimate strength of the precast concrete components and connection details (Fig. 10). The paving notch system failed at approximately 112 kips.

From the post-test visual inspection of the failed specimen (Fig. 10), it appeared that the failure of the system was a result of abutment concrete cracking. After initial cracking, the research team continued to load the specimen until the paving notch severed from the abutment. In general, the failure pattern was similar to what was observed in Phase 2.

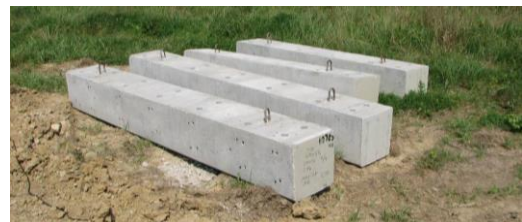
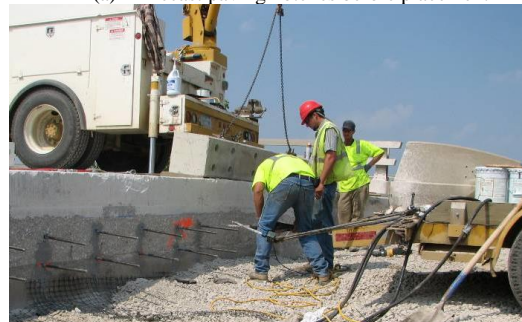
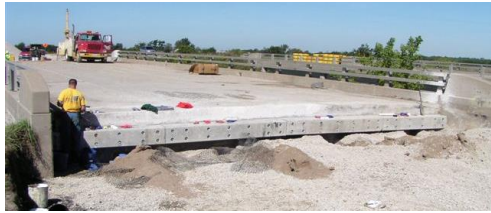
(a) Precast paving notches before placement

(b) Anchoring stainless bars to the abutment

(c) Applying epoxy at the adjoining surfaces

(d) Installation completed

Figure 12. Photographs showing the installation of the precast paving notch system.

The installation of the precast paving notch system required preparation and attachment procedures similar to those followed during the laboratory test phase. Photographs of the installation of the precast paving notch system are shown in Fig. 12. A list and brief description of the principal installation steps are summarized as follow:

- Following closure of the bridge, a strip of approach pavement near the bridge was removed and the existing, deteriorated paving notch was saw-cut and removed until sound concrete was identified.

- Several holes, 12 in. deep, were drilled into the existing concrete abutment. The location of the holes was based upon the geometry of the precast paving notch and various field measurements. Then, epoxy grout was injected into the drilled holes followed by the insertion of 3/4 in. diameter stainless steel threaded bars. Note that the holes in the abutment were drilled slightly larger than the stainless steel bars to provide tolerance for field variability and improved workability.

- The precast paving notch system was placed with special care so as to not damage the paving notch and the threaded stainless bars. Prior to placement, the adjoining face of the precast paving notch system was roughened to a coarse broom texture to enhance the bond between the abutment and the paving notch.

- Epoxy was then applied to both faces of the adjoining surfaces. The epoxy material used was suitable for bonding hardened concrete to hardened concrete and was proportioned and applied according to [9] the manufacturer's recommendations. The set time of the epoxy was such that final bolt-tightening was completed before the epoxy pot life expired.

- The paving notch system was attached and clamped to the existing abutment concrete with the stainless steel bars passing through the drilled holes and anchored to the abutment with heavy hex stainless nuts and washers.

- Excess epoxy squeezed out of the joint onto the surface of the precast paving notch was then removed. With concrete sealer applied to the precast paving notch end sections, the installation was completed.
