Structural Behaviour of RC Beam-To-Column Connection with Corroded Shear Reinforcement

Abstract—Corrosion of steel reinforcement in reinforced concrete structures is a serious factor affecting their lifespan. There are more and more studies devoted to understanding the influence of corrosion on RC structures. Recent studies have focused on shear strength deterioration of RC beams since shear failure are often sudden leading to disastrous consequences. However, there is still a lack of understanding when it comes to beam-to-column connections, particularly connections with shear critical beams. This study provides much needed information about the structural behaviour of shear critical beam-to-column connections with corroded shear links. Full scale samples were tested for that purpose. The deterioration was monitored under constant static loading. It was found that the targeted 20% corroded shear link resulted in 13.5 – 17% loss in ultimate strength. The rotational stiffnesses were also greatly affected. The crack pattern helped to interpret the load path and the subsequent deterioration of the structure.

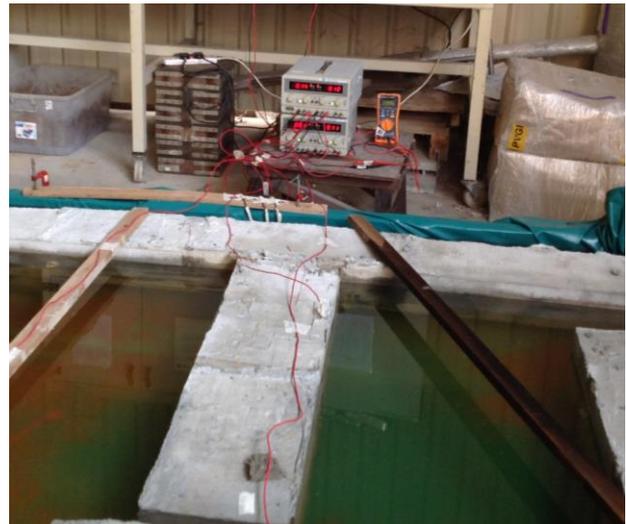
Figure 2. Corrosion process setup.

The accelerated corrosion was performed using 4% chloride solution in a purpose-built basin. A DC power supply with a limit of 3 V and a maximum of 3 A was used to apply a constant current of 0.25 mA/cm² to the specimens. The shear link was connected to the positive terminal as the anode and a piece of stainless steel bar was used as the cathode. All the other reinforcement bars were protected using K'mastic 5000 epoxy paint that provides high chemical and moisture protection to ensure that only the selected shear link is corroded. The targeted corrosion level was 20%. The accelerated corrosion time was calculated based on Faraday's first law as given below:

The specimens were soaked for 3 days prior to performing the accelerated corrosion. The corrosion test setup is shown in Fig. 2.

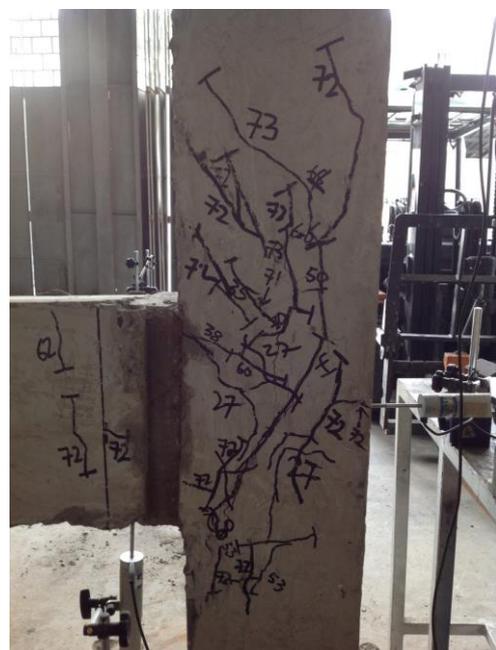
Figure 10. Crack formation at the joint for Sample – Control A.

The failure mechanism was closely monitored throughout the test and the cracks formation was recorded. All the samples failed in a similar fashion, with the initial crack forming at the beam-to-column joint region. The crack patterns for sample *A* – control and *A1* are shown in Fig. 10 and Fig. 11, respectively for illustration. The sketches of the crack patterns for samples *A* (control), *A1* and *B1* are provided in Fig. 12.
