# Evaluation of Epoxy Injection Method for Concrete Crack Repair

Sarah Griffin, Hossein Askarinejad and Brian Farrant

Department of Engineering and Architectural Studies

Ara Institute of Canterbury (Christchurch Polytechnic), New Zealand

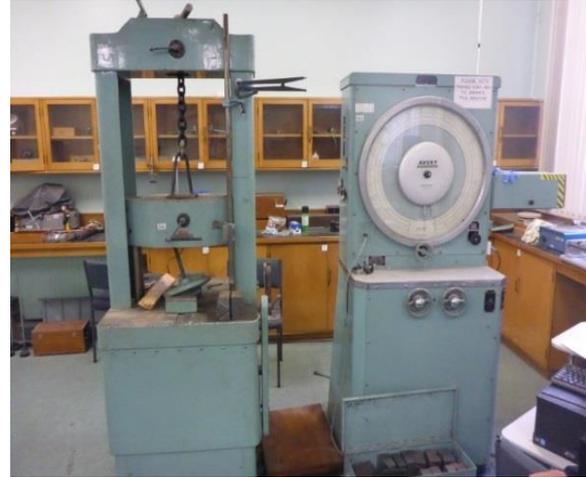
Figure 1. The Avery machine

The tests were undertaken with an Avery Universal testing Machine (UTM) at Ara's Engineering Laboratory. A view of the testing machine is shown in Fig. 1.

The beams were then transported to the testing lab where they were once again tested under flexural loading using the Avery machine.

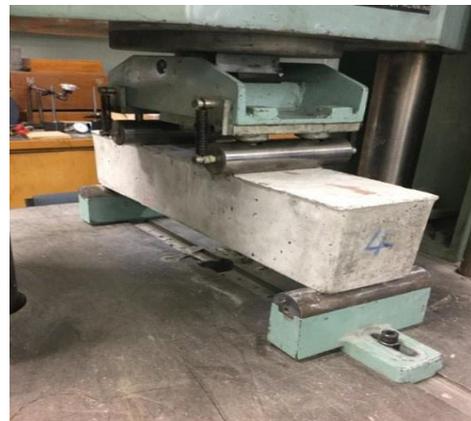
Figure 2. Test setup

The experiments were conducted using the third point loading method where a constant bending moment is applied to the middle 100mm of the beam span length. Fig. 2 demonstrates one of the test beams which has been set up ready for testing.

For the tests, first, the beams were placed on the two support blocks and ensured that there is an equal amount of overhang at each end as shown in Fig. 2. Next, the load-applying blocks were adjusted to be in contact with the upper surface of the beam. Then, the load was applied at a constant rate until the beam reached its tensile strength causing the breakage.

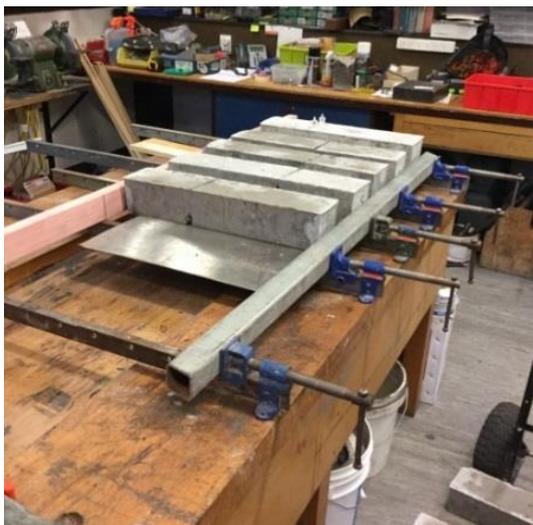
Figure 3. Clamp system

The cracked/fractured beams were carefully transported to the concrete lab where the repair process (epoxy injection) was carried out. A clamp system was used to hold the broken beams in position during the epoxy application process. The clamps were laid out at even spaces on a work bench and thin sheets of steel were placed between the clamps which provide a flat stable

surface to rest on while the clamps were being tightened as shown in Fig. 3.

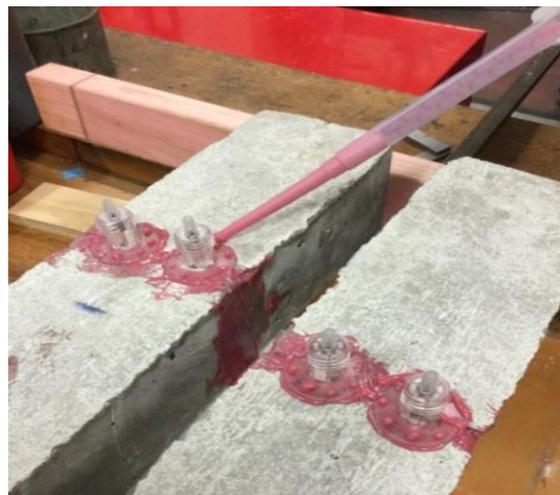
Figure 1. Injection port application

For epoxy Types1 and 2, each beam required two injection ports to be fitted for the epoxy to be injected into. A small amount of sealant was applied to the back of two ports which were placed over the visible crack. These are placed between 100mm and 500mm apart, depending on the size of the concrete specimen. In this case, the ports were spaced 100mm apart. Additional sealant was then

applied around the sides of the ports and along the rest of the crack that was still exposed as shown in Fig. 4.

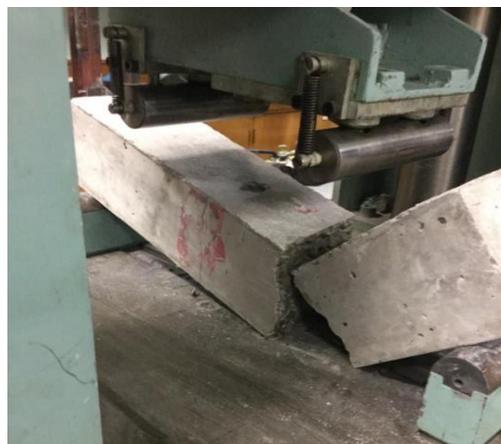
All of the beams failed within the middle third (Fig. 5). This was expected due to the third point loading method which allowed for a constant bending moment in the middle segment of the beam spans.

Figure 5. Typical test beams fracture under the vertical load

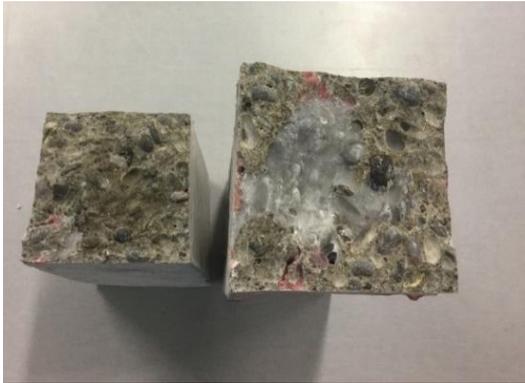
In the specimens repaired by Type1 epoxy, the failure occurred at the original crack line where the epoxy was visible in the fractured faces as shown in Fig. 6. On the other hand, the specimens repaired by Type2 and Type3

Figure 6. Failure through the epoxied section (original fracture line) – Typical scenario for beams repaired by Type1 epoxy

The average failure load ratio for beams repaired by Type1 is calculated as 0.71. In these beams, the fracture of the repaired beams occurred along the original fracture line which means the epoxy failed to resist the flexural tensile stresses generated in the epoxied sections.
