# Durability of New Roads: Case Study of the Algerian East West Highway

**Abstract**— The goal of this paper is to analysis the damages sustained by the new Algerian highway called AutoRoute east-west. Many sections of this new infrastructure are closed or partially opened after two years of exploitation. The main damages are in relation with the structure layers of the road and with the deformation of the side of embankment in the sloped sites. This linear network must have a length of seven thousand kilometers and realization duration of ten years. The road section situated in Algeria has one thousand and two hundred kilometers and its study has start in 1997. In September 2012, the Minister of pavement declares that the final cost is twelve milliards in us dollar (12 billion us \$). The study begins by the description and the analysis of the damages sustained by this structure and it finish by the identification of the causes who have generated these faults.

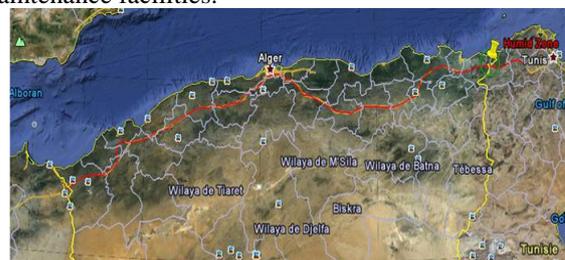
Figure 1. Path of the actual Algerian section of the Highway

The Algerian section is part of the 7,000 km of the North African AutoRoute, which is being developed in two stages: East and West. The figure 1 shows the path of the Algerian section of the highway. The road section situated in Algeria has one thousand and two hundred kilometers and the study of section located in Algeria starts in 1997 and the beginning of work starts in 2007 and must finish at first January 2011. The first phase, the East-West Highway, involves the construction of a 1,216 km section linking Annaba in the east to Tlemcen in the west, passing through 24 Algerian provinces. The first section is further divided into three sub-sections: the Eastern section, Central section and Western section. The development will have 12 tunnels, 70 viaducts, 60 interchanges and 390 structures. It also includes a provision for building truck stops, service stations and maintenance facilities.

The highway passes through many regions with different geography. Indeed, the west border of Algeria is classed as zone with weak precipitations, the centre is classed as zone with middle precipitations, and the East is considered as humid zone. The corps of pavement was designed with a uniform structure. The Fig. 1 shows the Path of the actual Algerian section of the Highway.

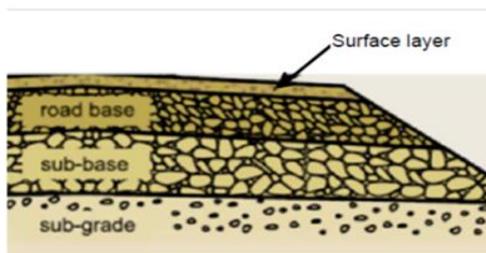
- Sub-base: broken stone (40 cm thickness),
- Road-base: gravel (30 cm thickness),
- Surface layer: bituminous mixture (6cm thickness).

The Fig. 2 shows the different structures of the layers that compose the highway.

Figure 2. Structure of road pavement

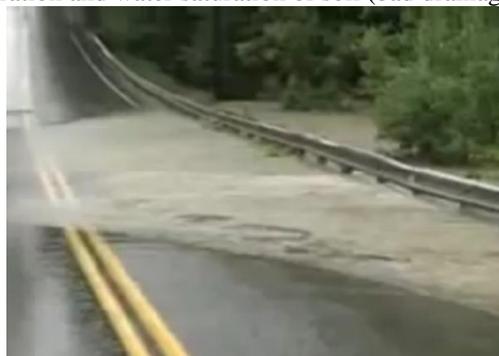
The Fig. 3 shows the damages generate by flooding on the road because of absence of rainwater drainage.

Figure 3. Flooding of road caused by absence of rainwater drainage

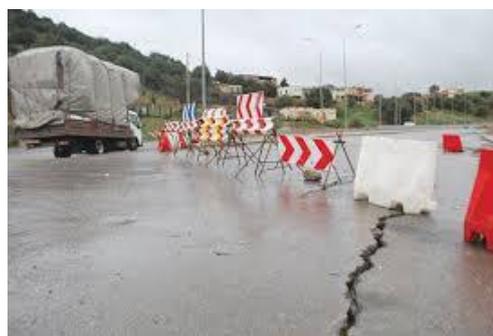
The Fig. 4 shows the longitudinal fissure caused by a lack bearing of structure of road by fatigue phenomenon.

Figure 4. Longitudinal fissure caused by a lack bearing of structure of road by fatigue phenomenon

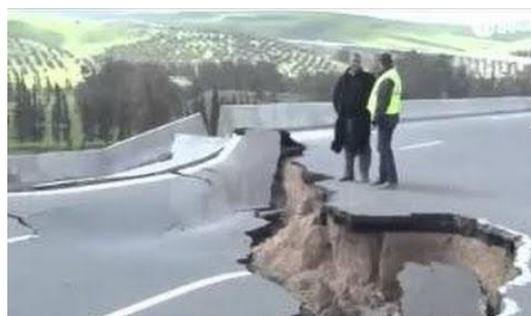
The Fig. 5 shows the collapse of road caused by settlement of soil.

Figure 5. Collapse of road caused by settlement of soil

The main advantage of compaction of soils used in embankments and fills is that it reduces settlement caused by consolidation of the soil within the body of the embankment. Through proper compaction, it is possible to limit later consolidation and settlement of the soils in a fill.

Although future settlements may not be entirely eradicated, the compaction may produce a uniform density of the soils and reduce this process to a minimum [7]. Also it may result in future settlements being more uniform and thereby limit the damage caused by it. The figure shows the graphs of dry density of different soils according to the moisture saturation.

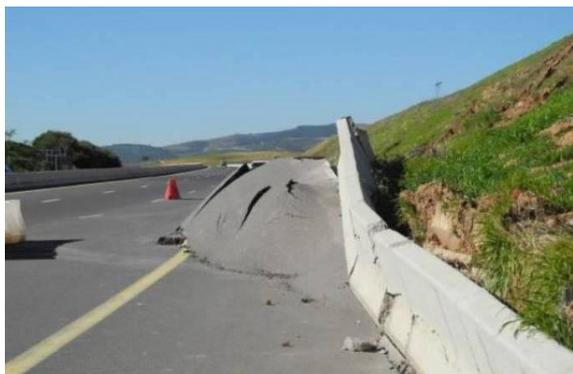
The Fig. 6 illustrates the Settlement of bank caused by landslide.

Figure 6. Settlement of bank caused by landslide

The deformation of the base of the slope is generated by the undrained soil and by the non-adequate angle of

the bank. The reinforcement of slope again landslide can to be realized by many artifices such as concrete walls, gabions walls, nails, anchors, etc. These recommendations are known in the engineering literature [8]. Indeed, every solution must be chosen in relation with the environment and the costs [9].

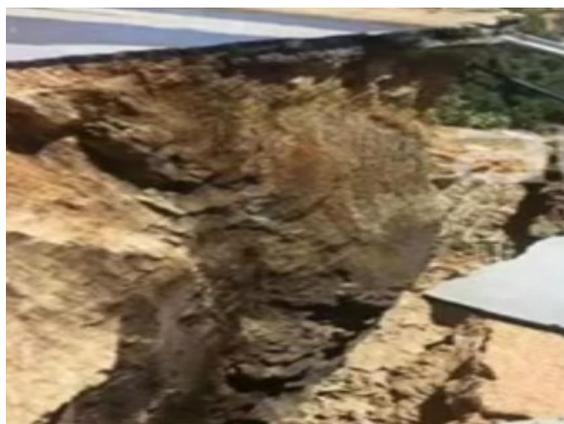
The Fig. 7 illustrates the Collapse caused by a geological variation in the soil and water infiltration; and Fig. 8 shows the Settlement of soil caused by water infiltration and water saturation of soil (bad drainage).

Figure 7. Collapse caused by a geological variation in the soil and water infiltration

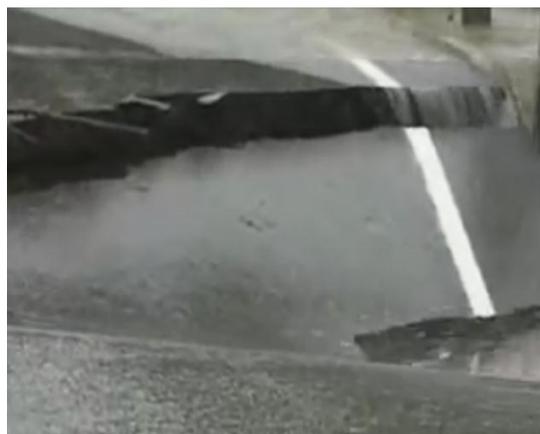
Figure 8. Settlement of soil caused by water infiltration and water saturation of soil (bad drainage)
