# Structural and Non-Structural Assessment of a RC Water Tank

**Abstract**—This work presents a case study that aimed to assess the structural safety of a RC water tank located in Fátima, Ourém Municipality – Portugal. To perform the assessment an initial survey was conducted and supported by a non-destructive test campaign that allowed the development of a numerical simulation that will allow to evaluate the safety level and to support the definition of the structural retrofitting and rehabilitation needs.

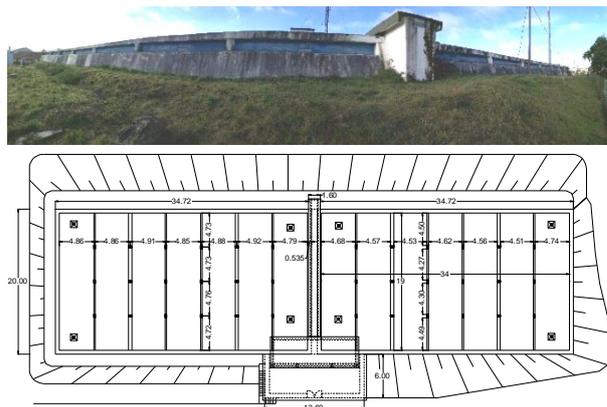
Figure 1. Water tank

The water tank under study was built in 1967 by the religious order “Monfortinos”. At the present time it is managed by the water concessionary Be Water S.A. - Águas de Ourém. It has a rectangular and axisymmetric geometry divided into two cells. Each cell has 34 m long, 19 m wide and has a height of 4,1 m between the bottom slab and the top slab, a partially precast rib and block slab, as shown in Figure 1.

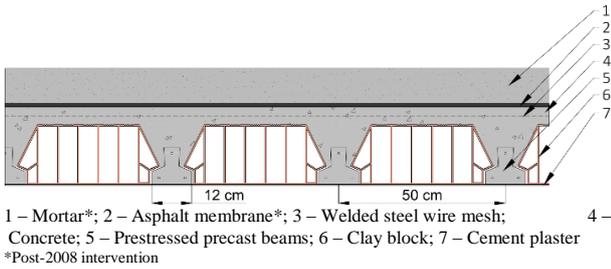
Figure 2. Top slab cross-section

The structure is made of six (6) transversal reinforced concrete frames, composed by columns, oriented in two orthogonal directions, rectangular beams, lightweight slab and outer walls. These walls have a trapezoidal shape in cyclopean concrete, with a variable width varying from 1.80 m at the bottom and 1,0 m at the top 1,0 m) and are 4,1 m tall. The one-way slab's precast beams are 50 cm apart from each other and are supported by the concrete frame. Figure 2 illustrates the cross-section of the slab and TABLE I lists the geometry of all structural elements.

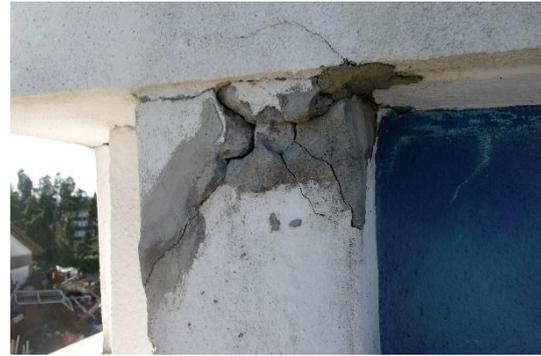
Outside the tank it was possible to observe high levels of cracking on the exterior of all walls, which is more pronounced in the non-structural vertical elements, as showed in Figure 3, and in the interface between the walls and the slab. It is also important to note the presence of vegetation in some points of the tank next to the waterproofing membrane of the technical gallery (Figure 4), at the top of the same gallery and next to the roof of the entrance of the tank.

Figure 3. Cracking in a non-structural column

The only exception is the cracking pattern exhibited by the columns that joint the slab in its contour, explained by the forces on these elements for the fundamental combinations associated with the seasonal variation of temperature. The same type of action also explains the cracking pattern observed in the cover slab.

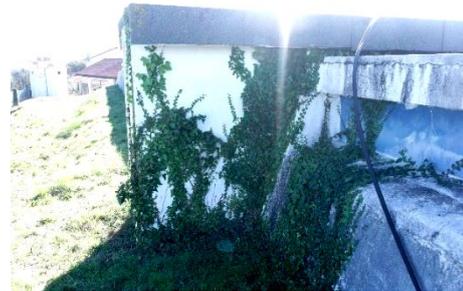
Figure 4. Vegetation

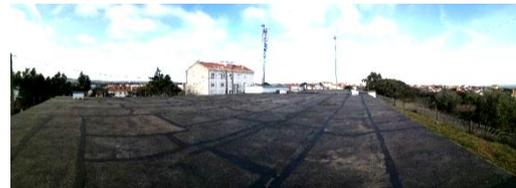
In the top slab was observed cracking with a regular pattern (Figure 5). This pathology has an impact on the tank due to the water infiltrations.

Figure 5. Cracking of the top slab - Overview

The cracking verification is verified for the positive bending moments, but for the negative moments it is not. These results explain most of the cracking pattern observed on the top of the slab, and above the frames. Fig. 22 shows the cracking pattern observed on the top slab as well as the principal tensile stresses due to the temperature action.

- a) Shrinkage of the cement mortar used in the coating layer of the slab in the 2008 intervention;
- b) Multiple expansion and contraction cycles of the materials due to thermal and humidity variations, intensified by the dark colored finishing of the slab;
- c) Accelerated aging of the mortar due to exposure to the natural elements such as wind, humidity, solar radiation, temperature and frost.

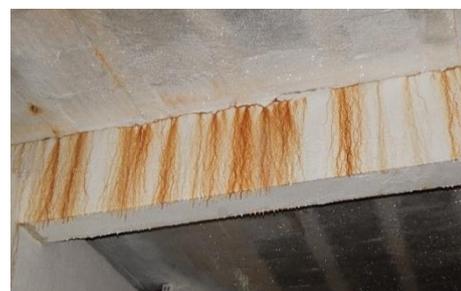
In the interior, there are detachments of the wall's plaster, cracking, and infiltrations caused by the damages in the slab over the entire length of the structure (Figure 6).

Figure 6. Pathology: Cracking/Infiltration

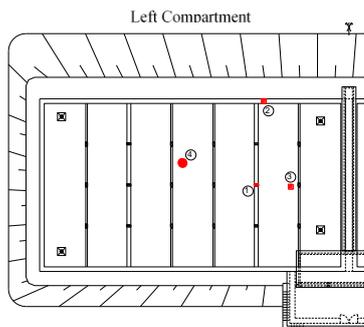
Figure 7. In-situ tests layout

To support the visual survey performed and to improve the knowledge about the structure behavior a campaign of non-destructive tests was planned and performed in the structure with the layout shown in Figure 7.

- 1 (Column): Rebar detection; Rebound test; Windsor probe
- 2 (Wall): Rebar detection; Core drilling; Rebound test; Windsor probe
- 3 (Bottom slab): Rebar detection; Windsor probe
- 4 (Top Slab): Core drilling

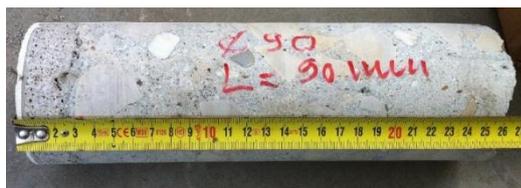
The concrete core samples extracted from the structure, as seen in Figure 8, were prepared and tested according to the standard EN 12504-1:2009 [3]. From this test, the compressive strength obtained was of 37,7 MPa.

Figure 8. Core drilled concrete sample

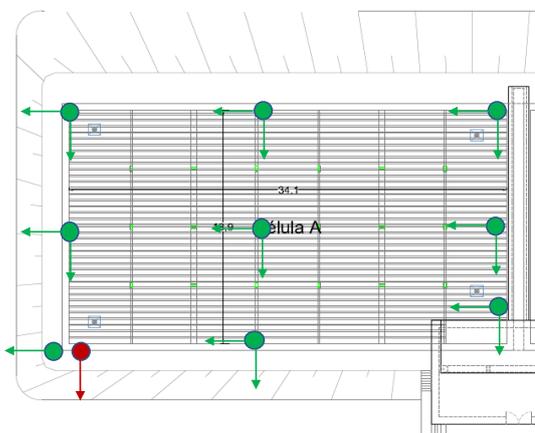
For this purpose, measurements of the structure were made, without forced vibration, aiming to obtain the modal response to support the development and calibration of a numerical model according to the layout shown in Fig. 9. The measured frequencies are listed in TABLE and the corresponded modes of vibration are represented in Fig. 10.

Figure 9. Accelerometer locations and measurement direction

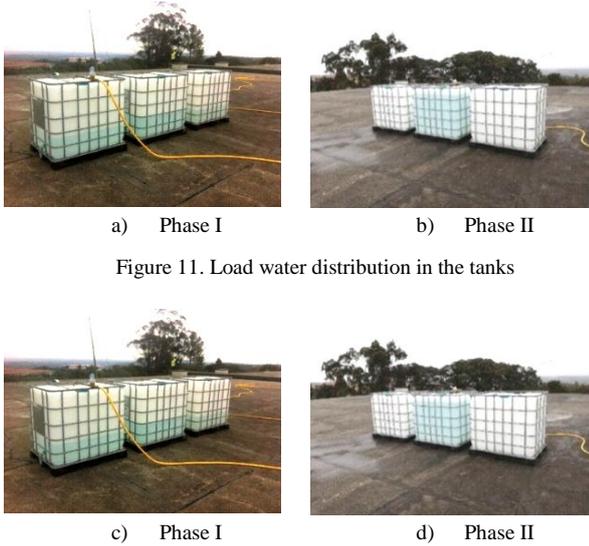
For this purpose, 3 plastic tanks were used, with a capacity of approximately 1000 liters each and dimensions of 1,20 x 1,00 m<sup>2</sup>. They were placed on a 1 m strip on the alignment of two columns. Thirteen load levels were considered between 180 l (60 l in each tank) and 1063 l (only in the central tank), divided into two phases. These load levels are represented in Table and Fig. 11.

Figure 11. Load water distribution in the tanks

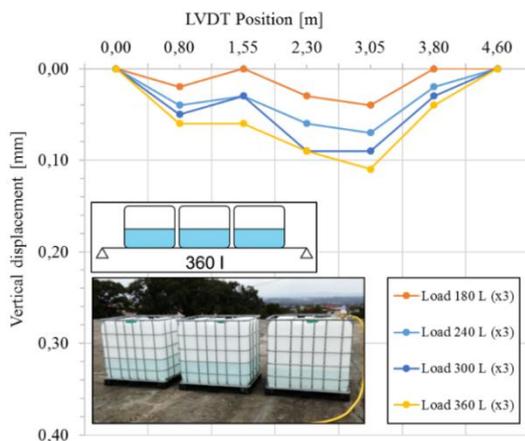
All deformations were recorded and the results are presented in Fig. 12 and Fig.13 for each loading phase. These results allowed to estimate the bending stiffness of the slab (37600 kN.m<sup>2</sup>/m) and verify that it is above the value presented in the manufacturer's catalog (30388 kN.m<sup>2</sup>/m).

Figure 12. Phase I Load/Displacement diagram

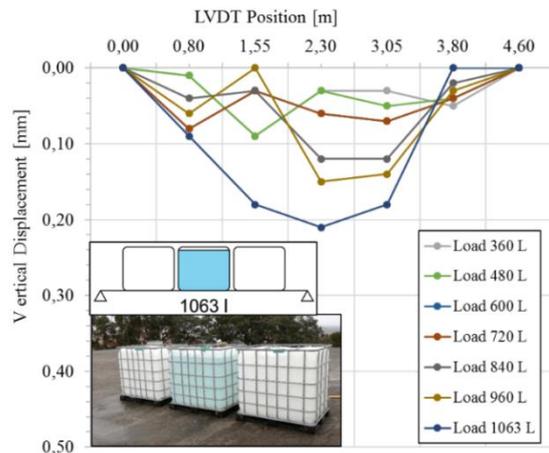
Figure 13. Phase II Load/Displacement diagram

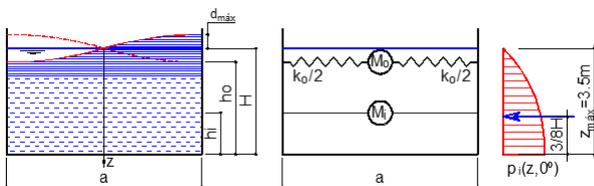
The use of a different damping coefficient for the water mass was needed to calculate the influence of the seismic action on the water mass and consequently the sloshing effect of the water on the exterior walls and possibly on the top slab. The *Housner* method [12,13] was used to quantify the dynamic action that the earthquake causes on the water and tank as well as the height of the sloshing wave ( $d_{max}$ ). In Figure 14 are represented the geometrical properties for the tank alongside with the representation scheme that assumes that the lower mass of water ( $M_i$ ) is attached rigidly to the tank at a proper height ( $h_i$ ), and a secondary mass of water ( $M_o$ ) will be excited by the ground (and tank) motion causing it to oscillate. This will exert an oscillating force on the tank's walls, represented by the pressure diagram ( $p_i$ ) and equivalent springs. These dynamic forces were added to the static forces.

Figure 14. Representation of the Hydrodynamic behavior

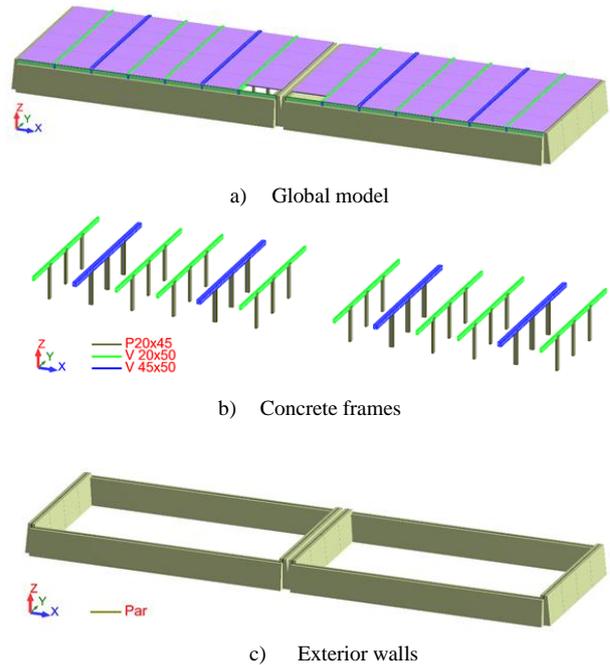
A 3D numerical model was developed, composed of bar elements, for the beams and columns, and 4 node plane quadrilateral finite elements for the slabs and walls, as presented in Fig. 15 a) to c). All supports in the base were considered with the displacement fixed.

Figure 15. Numerical model

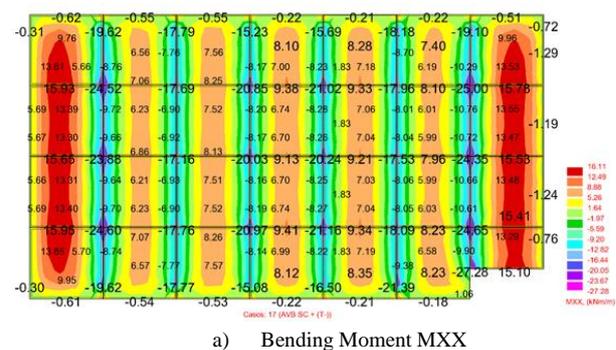
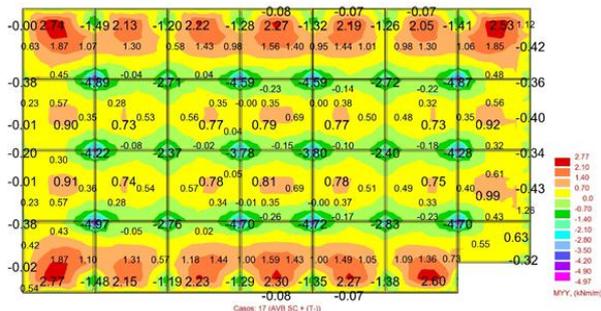
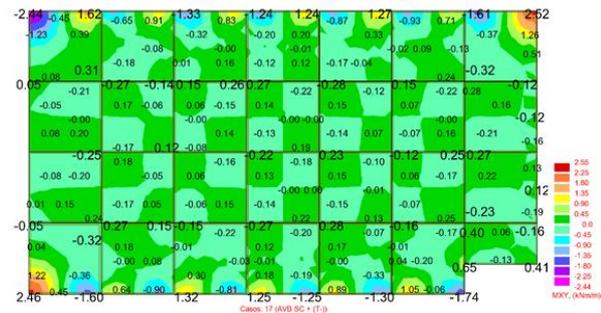
The maps for the resulting bending forces on the top slab, for the most demanding combinations, are presented in, Fig. 16 and for the shear forces in Fig. 17.

a) Bending Moment MXX

b) Bending Moment MYY

c) Bending Moment MXY

Figure 16. Bending Forces

The comparative results between the acting forces and the resisting forces are presented in TABLE VI. The sum of the bending moment ( $M_{XX}$ ) with the torsional moment ( $M_{XY}$ ) was considered for the total acting bending moment.

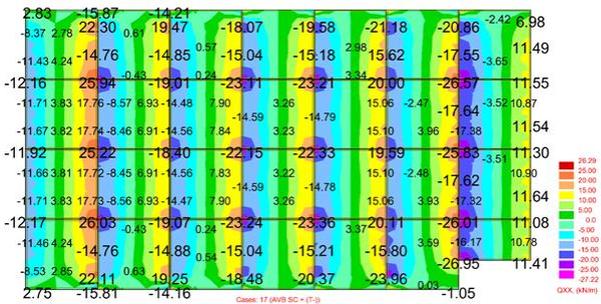
Figure 17. Shear Forces XX Direction

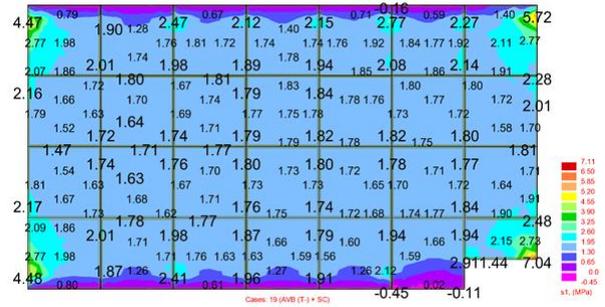
The principal tensile stresses acting on the top slab are presented in Figure 18.

Figure 18. Principal tensile stresses acting on the top slab

According to the limit states analysis the top slab was considered safe.

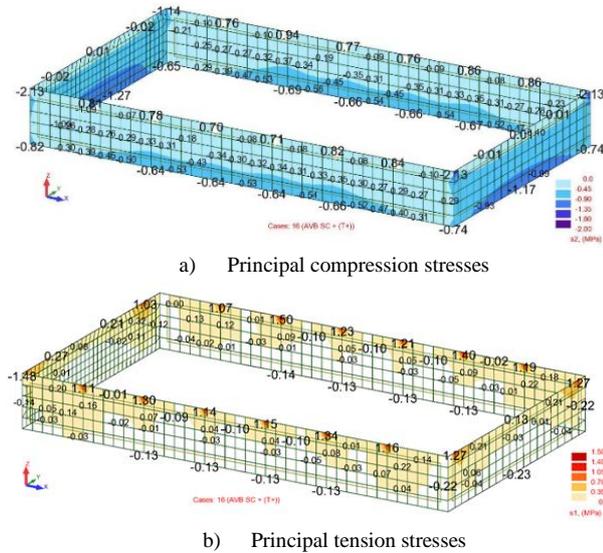
combinations with the corresponding capacity of the concrete. The principal stresses on the walls are presented in Fig.20.

Figure 20. Principal stresses on the exterior walls due to ULS load combinations

The maximum acting compressive stress of 1,50 MPa and the maximum acting tensile stress of 1,35 MPa proved to be much lower than the capacity of the concrete (16,7 MPa for compression and 2,20 MPa for tension), consequently verifying its safety.

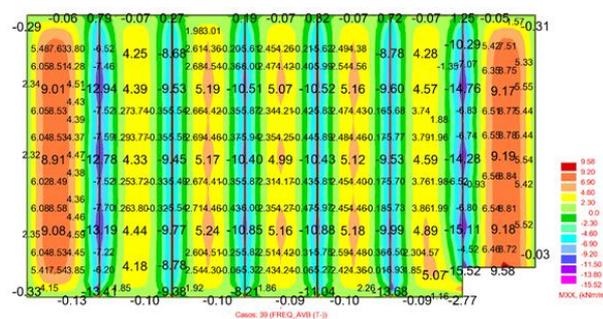
When performing the visual inspection, the main pathology detected was the cracking of the top slab. The bending moments for the frequent load combination are presented in Fig. 21.

Figure 21. Bending moments for the frequent load combination [kN.m/m]

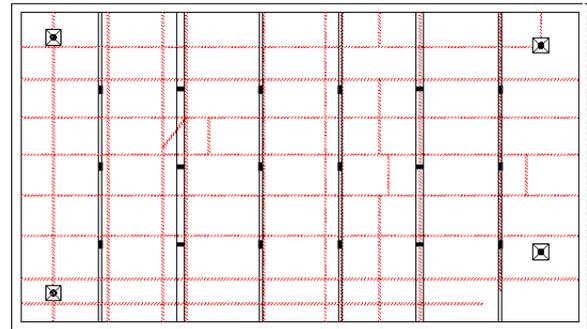
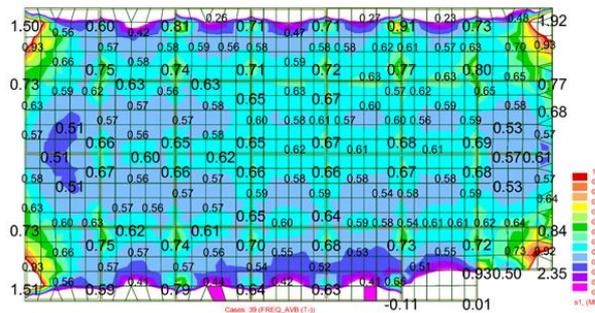
a) Exterior cracking pattern observed on the top slab

b) Principal tensile stresses on the top slab

Figure 22. Cracking pattern of the top slab

Fig. 22 b) clearly shows the location of the stresses that are superior to the plaster's tensile strength (0,5 MPa), forming a similar cracking pattern to the one present in Fig. 22 a).

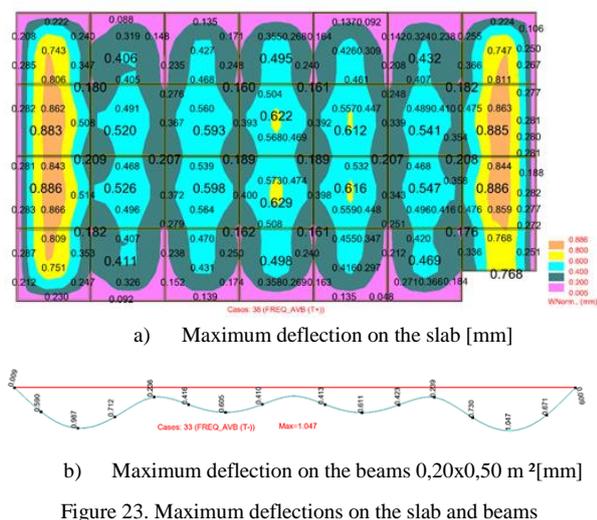
Deflection control for the beams and slab was performed limiting the long-term deflection to a maximum of span/400 (L/400). Figure 23 presents the maximum deflection obtained for the slab (3,10 mm) and beams (4,92 mm). Both proved to be within standard limits (L/400=12,83 mm for the slab and L/400=12,50 mm for the beams). It was concluded that the overload placed on the top slab in 2008 did not compromise the deflections limits.

Figure 23. Maximum deflections on the slab and beams
