Thermal Effects in Long-term Monitoring of ASR-Affected PC Gelber Hinge Bridge

Abstract—Crack expansion behavior due to temperature changes has a significant influence on the soundness of reinforced concrete bridges. In this study, the expansion of cracks by Alkali-Silica Reaction (ASR) was investigated using long-term remote monitoring on a four-span prestressed concrete (PC) rigid-frame bridge. To evaluate the workability of a deteriorated bridge, instead of only focusing on the deformation of cracks under external loads, the consideration of environmental temperature factor is also needed. By analyzing the relationship between temperature changes and displacement behaviors over time, the ASR-induced crack expansion trend had been obtained. After that, the prediction of ultimate status of this bridge under extreme and normal working conditions was discussed. The monitoring results showed that the ASR-induced cracks are getting wider over time. Furthermore, the results of the study also supported that since the objective bridge is designed with Gelber hinges, there are spaces for deformation between two spans, which make displacement easier to occur throughout the year, from spri

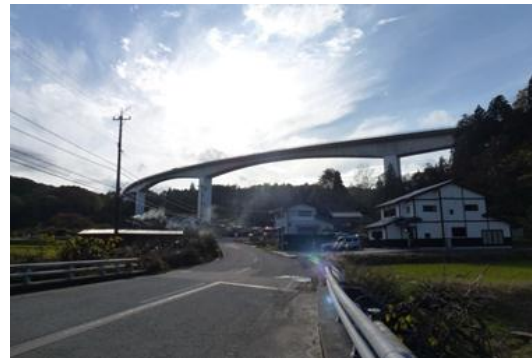
Figure 2. Overview of objective bridge

In this study, the objective bridge is a four-span PC rigid-frame bridge with 2 hinges, one is between P1 and P 2, other are for the connection between P2 and P3. The overview image of this bridge and position of hinges are shown in Figs. 1 and 2. This bridge was constructed in 1978 with the design of Gelber hinges, which is simple to design and elaborate. However as seismic activities in the Pacific Ring of Fire occur more frequently, the risk of earthquakes is increasing sharply. Therefore it is necessary to estimate the behavior of this bridge under seismic activities to figure out the most

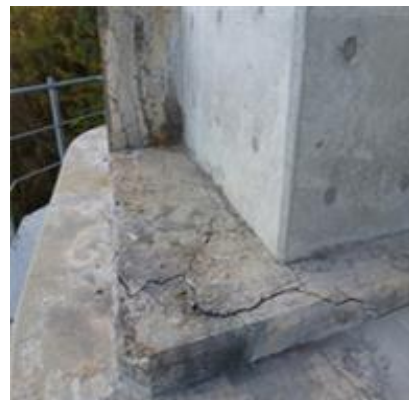
Figure 3. Concrete Jacketing

The cracks occurring in this objective structure can be seen on both piers and box girders. The deterioration is happening severely both outside and inside of the structure as shown in the Figs. 3-5. Fig. 3 shows that the reinforced concrete jacketing layer has some significant cracks due to the leaking water from the surface of the bridge. Moreover, inside the box girder, there are numerous thin cracks on the walls along the longitudinal direction (Fig. 5). There are also some damaging points at the joints (Fig. 4), which is believed to be the result of a collision between two girders at the hinge due to structural extension caused by temperature change.

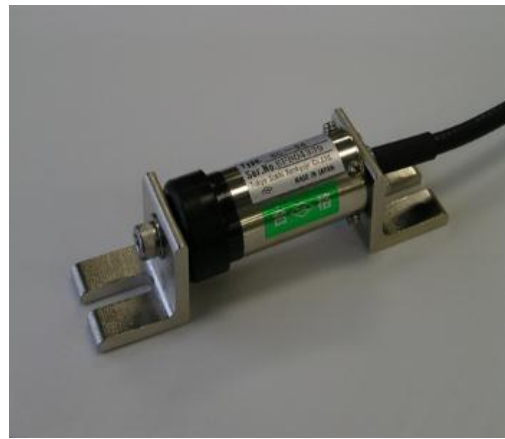
Figure 6. Crack Width meter

hinges and bearing pads, and crack width meters (KG-5A) are installed on the walls inside the box girder (Fig. 5). All devices are provided by Tokyo Measuring Instruments Laboratory Co., Ltd. The crack width meter (Fig. 6) is attached on the walls inside the box girder used to measure the width of cracks as shown in Fig. 7.

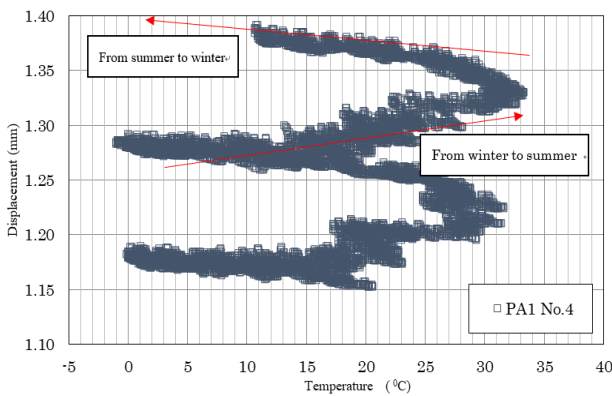
Figure 10. Relation between temperature and crack width at PA1 (No.4)

The width of crack near the top of the pier is shown in Fig. 10. The development of crack width at the middle and the top has nearly the same formation. Therefore, it can be concluded that temperature changes caused severe influences to the width of cracks in pier PA1. Furthermore, the value is much higher for the width at No. 4, about 1.4 mm in comparison with just 0.16 mm at No. 2. It presented that the width near the top is sharply more serious than ones in the middle of PA1. The crack development trend is the same at No. 3 and No. 4 near the top of the pier. Moreover, according to the intensive

increasing trend of width development as shown in Fig. 10, the cracks near the top are the weakest points of the PA1, which caused negative effects to the soundness of pier. Piers hold an important role for sustaining the workability of whole bridge structures, thus early maintenance methods are highly considered for this viaduct.

The first observation points in this study are at pier PA1. The positions of sensors are shown in Fig. 8, spreading from top to bottom of the pier. Figs. 9 and 10 show the correlation between temperature change and the width of cracks near the top and at the middle of the pier PA1. As shown in Fig. 9 the crack in the middle of the pier is continuously increasing its width throughout the years. The width increases significantly at high temperature around 30 °C to 35 °C, where the data has a vertical development trend. When temperature changes from summer to winter and winter to summer, the width keeps increasing but with more slightly gradation. Observing the ascending trend of width development, it can be seen that by the winter of 2018-2019, the width is expected to increase above 0.16 mm.

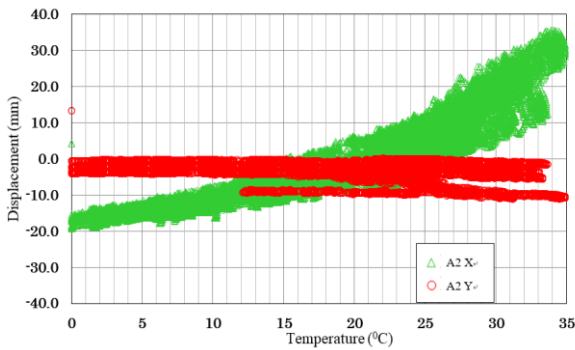
Figure 14. Displacement at A2 (X Y axis)

As presented in Fig. 14, the displacement at A2 has significant differences in comparison to those measured at PA1, especially on the Y direction. Especially, in the X direction, the displacement has the lowest value at about -20 mm, lower than ones at PA1, which is approximately -30 mm. Generally, the displacement trend on longitudinal direction is the same both at PA1 and A2. On the contrary, in the Y direction, the displacement at some point of temperature has decreased

to -15 mm. This behavior not only occurs at high temperature but also at a low temperature, at a wide range from 12 °C to 35 °C. However, at this range of temperature, there are also minor displacements, which show that the displacement at A2 is unstable and need further serious inspections for the more accurate conclusion.
