Research Paper

BEHAVIOR OF EXTERIOR BEAM COLUMN JOINTS WITH DIAGONAL CROSS BARS AND HEADED BARS

Dhake Pravinchandra D^{1*}, Jape Anuja S¹, Patil Hemant S² and Patil Yogesh D²

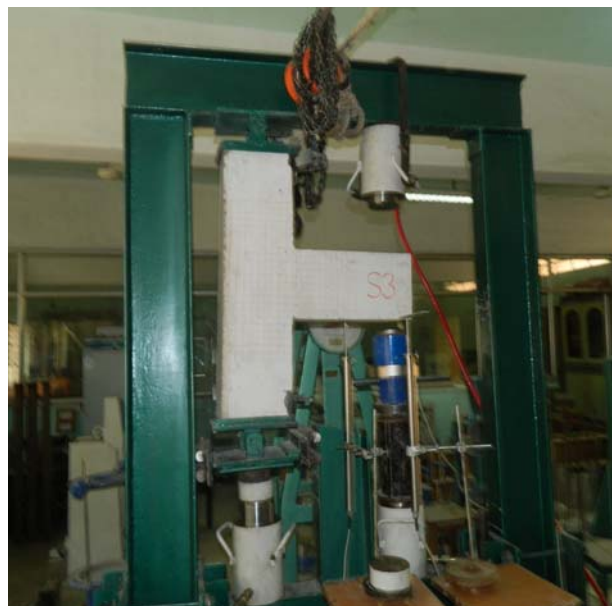
Figure 5: Test Setup

The specimen was tested in a reaction frame. The test setup is shown in Figure 5. A 1000

kN capacity calibrated hydraulic jack mounted vertically on the frame was used to apply axial load on the column. A constant load of 100 kN, which is about 15% of the axial capacity of the column, was applied to the columns for holding the specimens in positions and to simulate column axial load. Two ends of the column were given an external axial hinge support in addition to lateral hinge support provided at the top and bottom of the column. Another two 500 kN capacity hydraulic jacks were used to apply reverse cyclic load. The load was applied at distance 50 mm from free end of the beam face. The load was measured by inserting load cell in between the jack and the beam face. Loading was applied gradually such as 5, 10, 15, 20, ...70, 75 kN respectively for forward direction and 5,10,15, 20,...70, 75 kN, respectively for reverse direction. Figure 6 shows the loading history in terms of applied cycles versus load. Two LVDTs were used to measure deflections. The deflections were measured at the beam free end tip (at loading point) and at distance 175 mm from column face along beam.

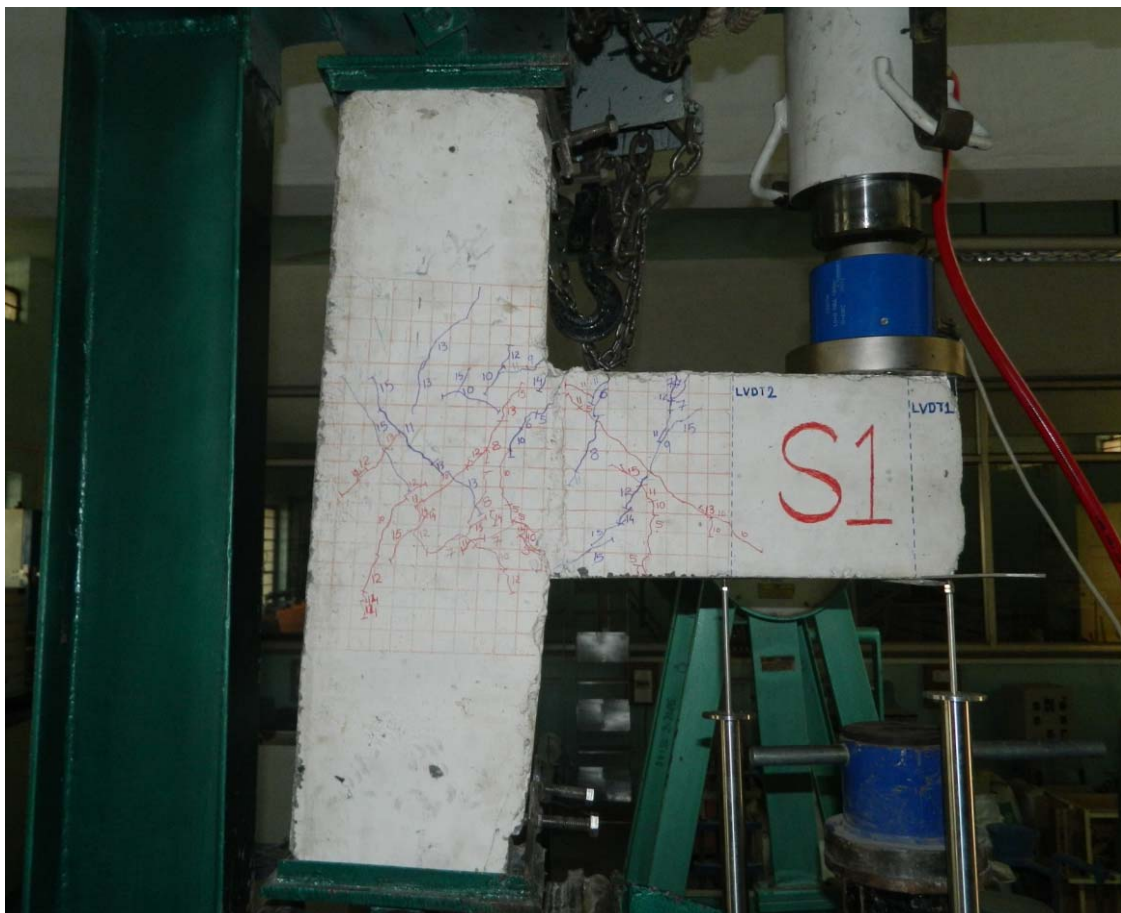
Figure 7: Crack Pattern of Joint S1

Figure 7 to 10 show the crack pattern and the loads at which cracks appeared.

The diagonal first crack at the joint region initiated at 25 kN load in joint S1 and S2 whereas in joints S3 and S4, it initiated at 35 kN load. The first crack at beam interface initiated at 25 kN load in S1, 20 kN in S2, 15 kN in S3 and S4. With further increase in loading, the cracks propagated further and

initial cracks started widening. At each cycle some new cracks formed. In joint S1 the cracks are distributed on entire beam column joint. In specimen S2 major only five cracks occurred, two diagonal 'x' crack in the joint region, one along the beam interface and two 'x' cracks in the beam portion. In Joint S3 only four major cracks appeared, one along beam interface, two 'x' cracks in the beam portion and one diagonal crack in the joint region. The diagonal crack in the joint region which initiated in 7th cycle, propagated further directly in the 13th cycle. The crack pattern of S4 is almost same as that joint S2 with the main difference that the diagonal cracks propagated in parallel lines. This difference in the crack pattern is due the arrangements of heads in orthogonal planes. The cracks in joint S3 had not widened much more as compared to other joints. After occurring initial cracks, increase in load was observed. It may be due to the following reasons. During cyclic loading, when unloading takes place, tip of the crack becomes blunt, and during reloading the specimen, more energy is required to propagate the crack or to change the direction of propagation from the blunt crack tip. This in turn increases the ultimate load (Ganeshan, 2007). The strength parameters and energy dissipation among different joint specimens are compared and reported in Table 1.

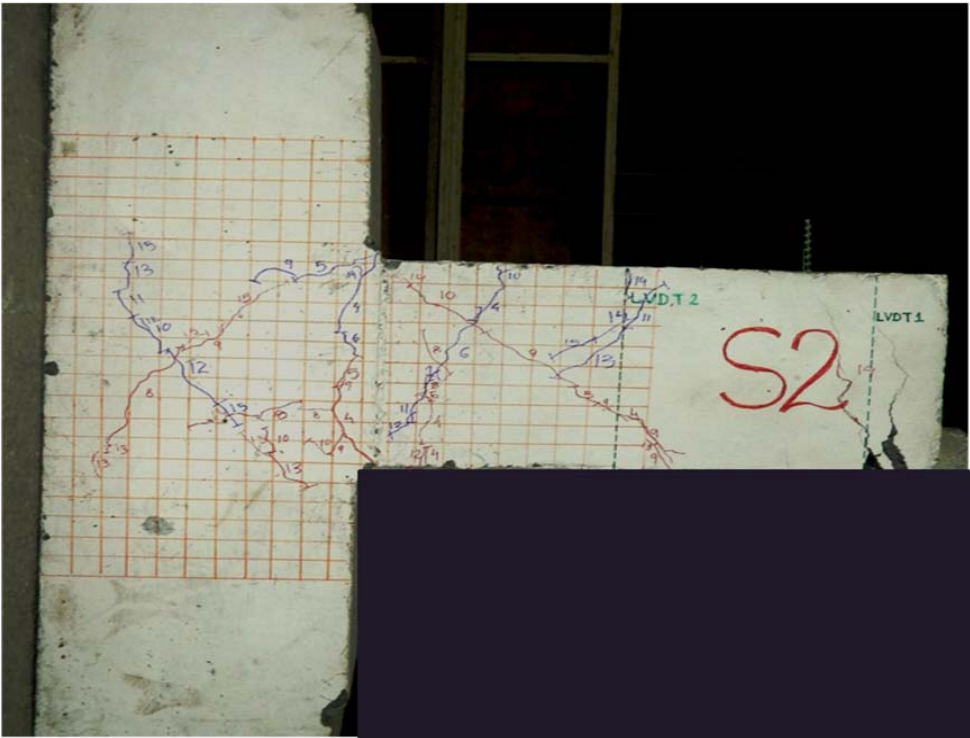
Figure 8: Crack Pattern of Joint S2

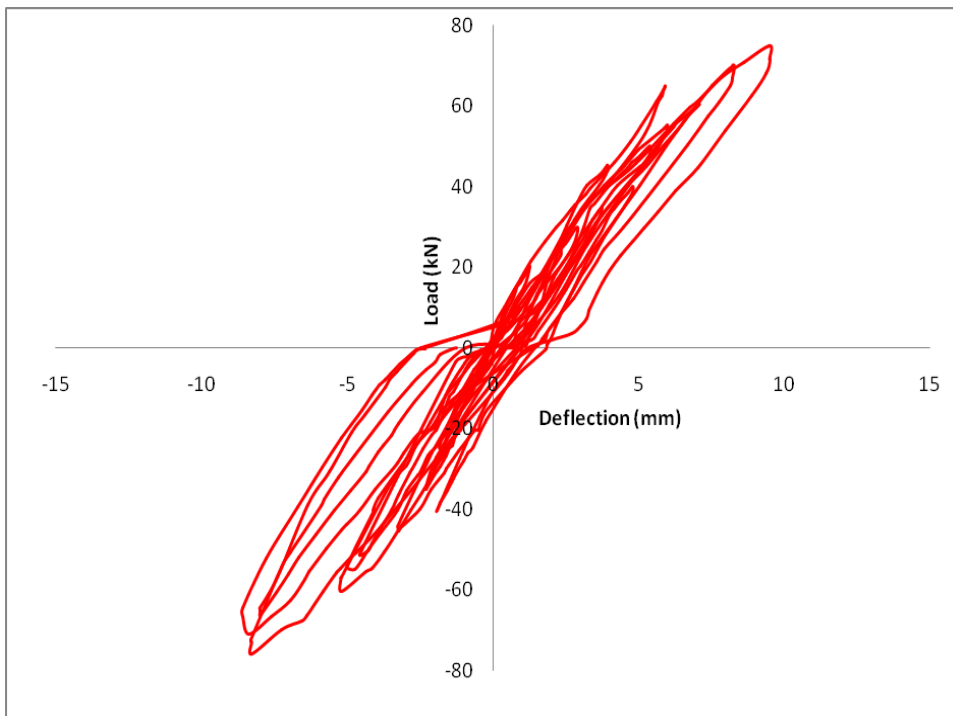
Figure 12: Load - Displacement Hysteresis Loops of Joint S2

Figure 11 to 14 show the load Vs. deflection graphs-hysteresis loops for joints S1, S2, S3 and S4, respectively.

The load-displacement hysteresis loop for joint S1, S2 and S4 exhibited almost same ultimate strength, Joint S3 failed at 70 kN ultimate load, but the failure was not at the junction or beam interface but in shear at the load point. The loops are much closely spaced for Joint S3. Joint S4 had shown large displacements during downward cycles.

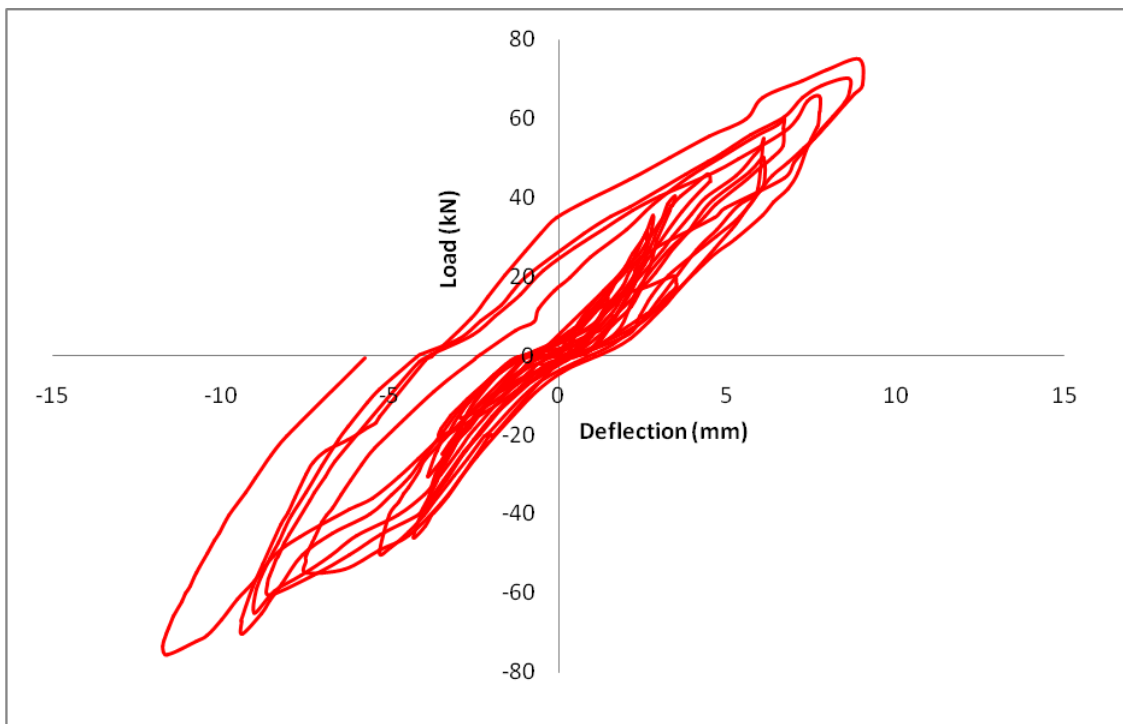
Figure 14: Load - Displacement Hysteresis Loops of Joint S4
