Research Paper

# EXPERIMENTAL STUDY OF LOCAL BEHAVIOR OF STRENGTHENED REINFORCED CONCRETE SHORT CORBEL BY BONDING CARBON FIBER FABRICS

Ivelina Ivanova<sup>1\*</sup> and Jules Assih<sup>1</sup>

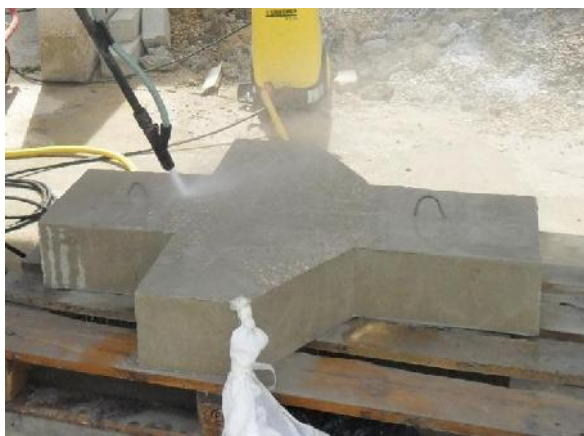
The surface preparation was of primary importance and calls for care (Figure 1). Preparation of concrete surfaces must be carried out to remove any loose or weak material, oil, grease, etc. In this case grit blasting was being the good method. The four corners of the corbel are rounded to reduce the decrease in strength and to prevent tearing of the composite material. Preparation of surface should be carried out just prior to the bonding operation to prevent any

Figure 1: Surface Treatment by Sandblasting

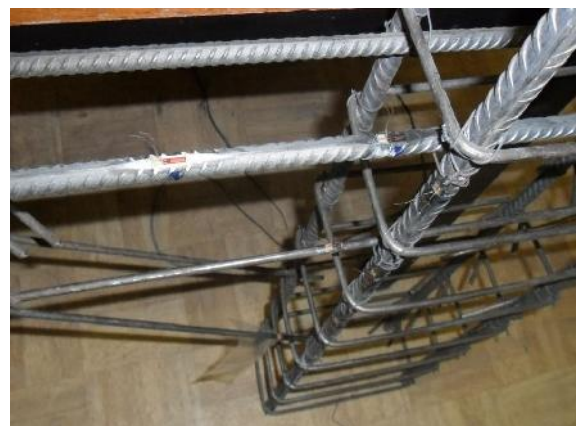
Figure 2: Position of electric gauges on underwood of reinforced concrete corbel

gauge factor 2.09. The strain gauges are attached to each of the experimental specimen. Precision strain gauges length of 5 mm (Figure 3) are used to measure the strain on the main steel reinforcement (Figure 2) as well as horizontal frame, steel tie rod placed along the tension and the compression strut. The strain gauges on the face of the corbel are placed in shear span between the corbel and the column. Two of gauges length of 10 mm are placed on the composite fibers plate surface and one gauge length of 30 mm on the concrete.

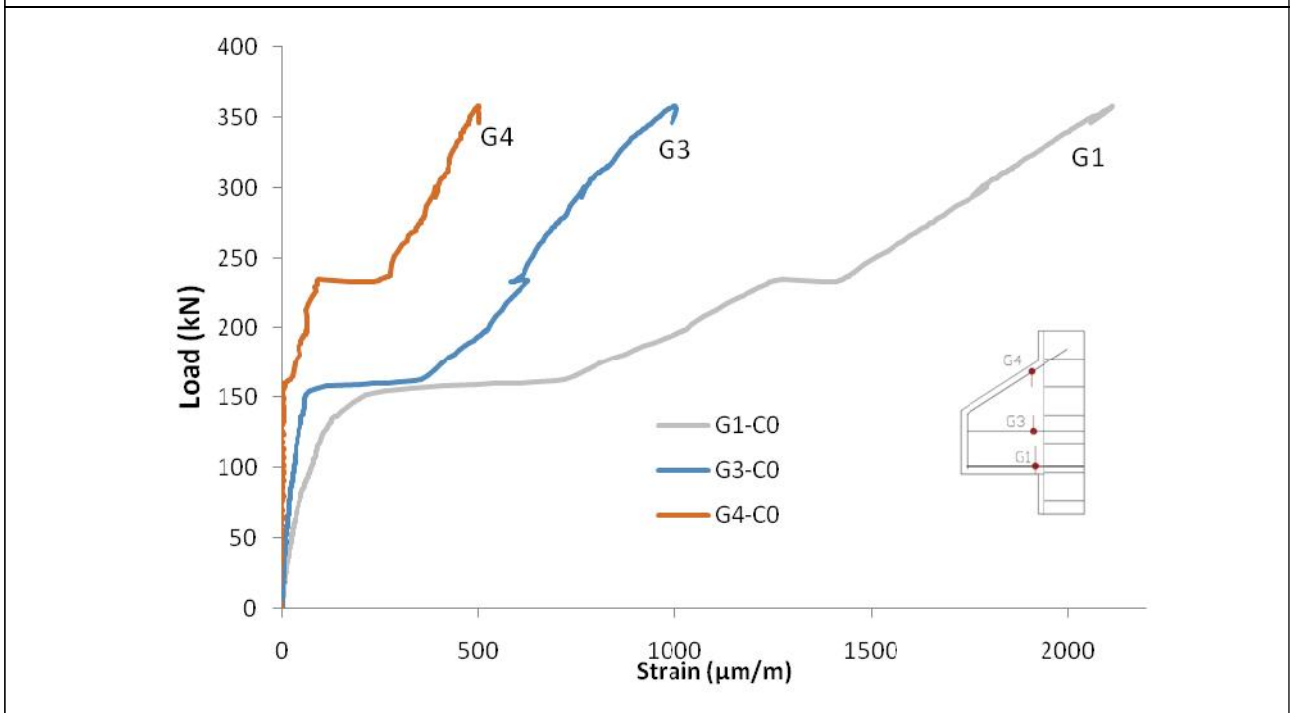
Figure 4 shows the deformation in recessed section of the corbel. Deformations are higher in the tension of the console until mid-height, so bond a plate that you can reconnect efforts more effectively.

Figure 4: Local Strain of Steel in Cross Section of Reinforced Concrete Corbel

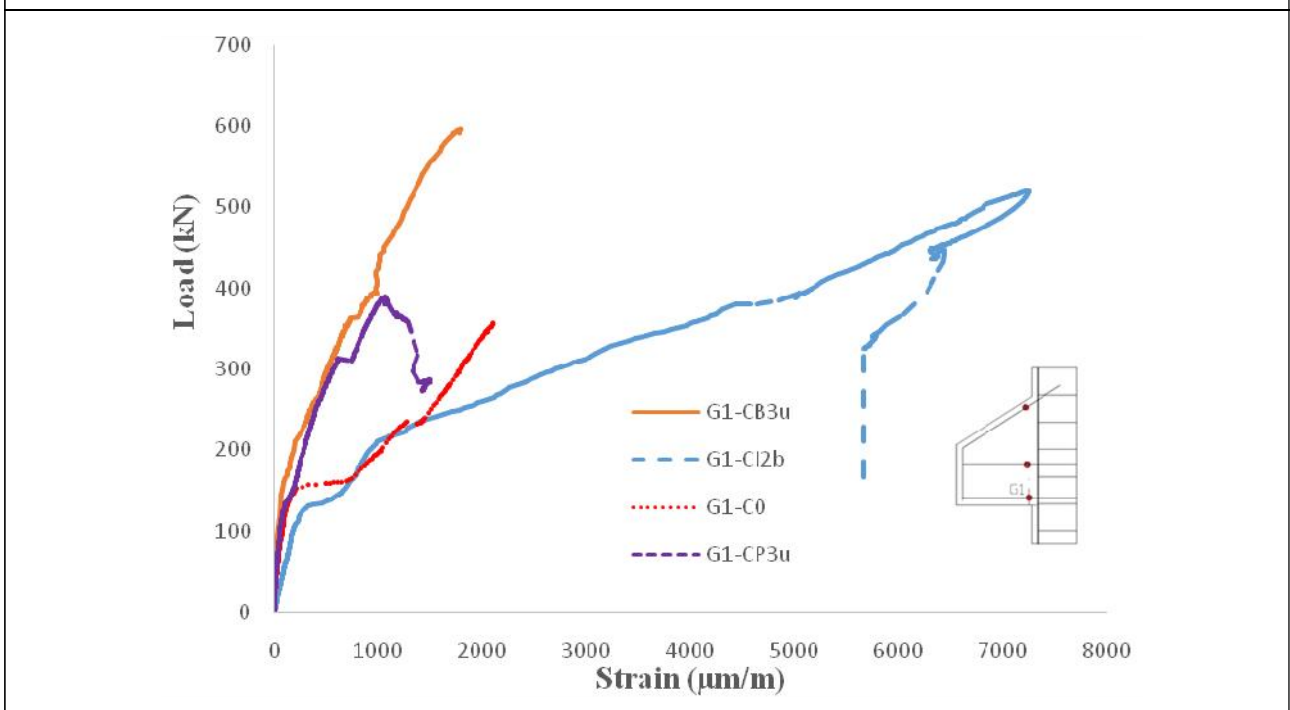
The results shown in Figure 5 the comparison of local steel deformation in cross section of strengthened reinforced concrete corbels CB3u, CP3u, CI2b and C0. Containment effect is evidenced by the reduction of deformations and a third of charge more than twice between Cb3u and C0. In the case of strengthening, CI2b configuration appears effective, insofar as crack is sewn by

Figure 5: Comparison of Steel Strain in Cross Section (point G1) of Strengthened Corbel

bonded carbon fiber fabrics to 45°. Confinement effect disappears as in the other

two cases. Strains are more important (~7000 µm/m). Recovery strengths in the tie rod steel

causes a local yielding which causes high deformations. Strengthened reinforced concrete corbel by bonded carbon fiber fabrics trips to 45° has a ductile mechanical behavior. However, the result that CP3u shows a similar behavior as CB3u, provided to ensure an anchor to prevent detachment of the plate.

First flexural cracks appear at 140 kN and then appearance of the bearing at 365 kN. Probably the appearance of diagonal cracks plays a lot because of the positive move in after the landing. It shows the comparison of curves obtained by gauges "G1" (steel tie local deformation) for four different corbels. These curves are compared to reference reinforced

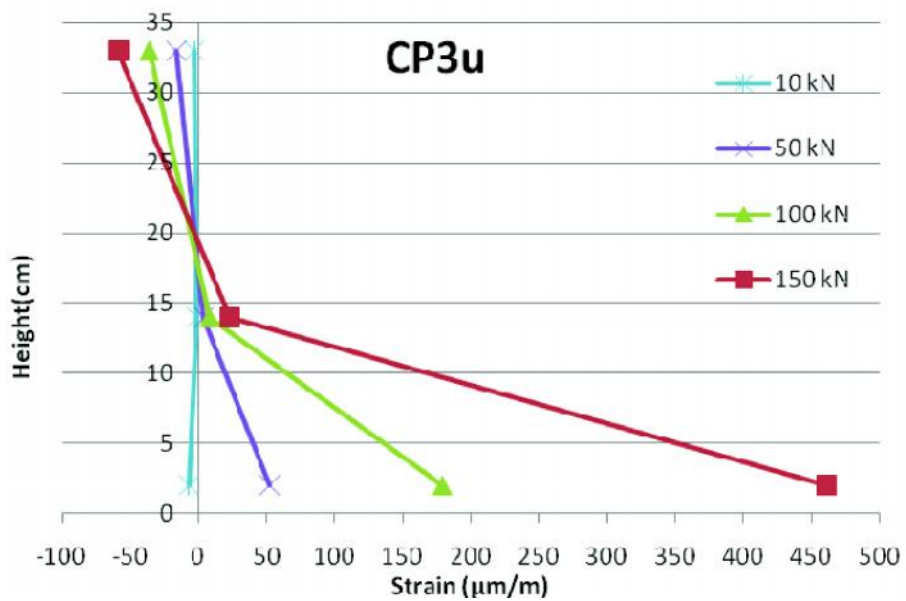
Concrete surface strains at a section close to column face of the tested corbels were measured by using three strain gauges over the depth of the corbel. Figures.6 and 7 show the concrete strain distribution over the corbel depth for all corbels at different load levels. In these figures, it can be seen that the strain distribution was approximately linear in tensile and compressive zones at low load levels, and then became increasingly nonlinear at the tension zone at higher loads due to cracking effect.

Figure 6: Position of Neutral Axial Versus Applied Load for CP3u

For all tested corbels, the neutral axis was shifting upwards after increasing the load beyond than the load at first crack. The position of the neutral axis for small load (10 kN) is about 15 cm, for which reason the width of the plate is less than or equal to this value.

The bonding composite carbon fiber fabrics slightly changes the position of neutral axis. But for loads less than 150 kN, the strain distribution in cross section appears linear. Beyond this value, the strain distribution is non-linear as in Figure 6 and 7.

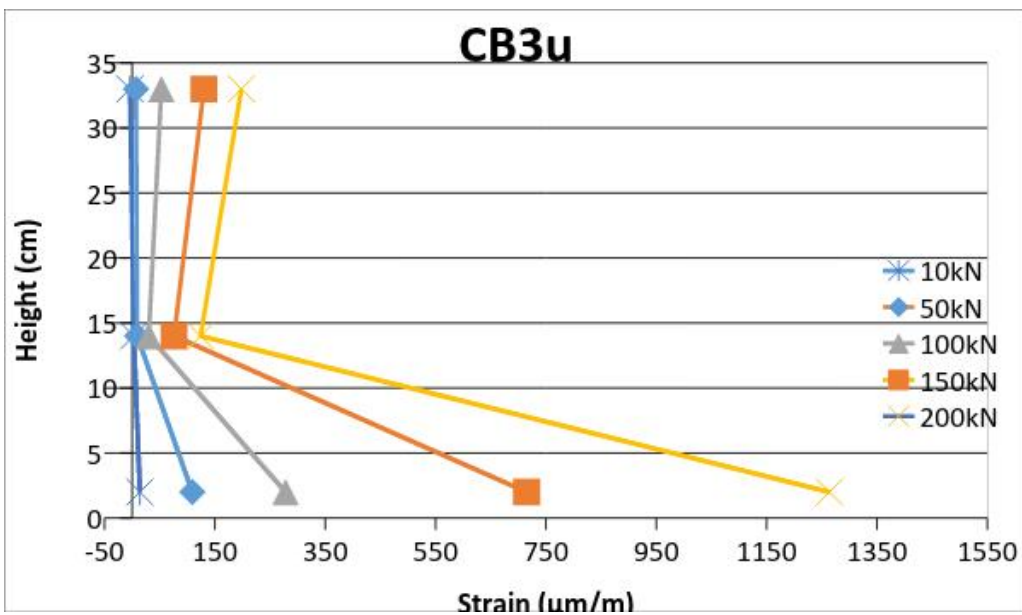
Figure 7: Position of Neutral Axial Versus Applied Load for CB3u

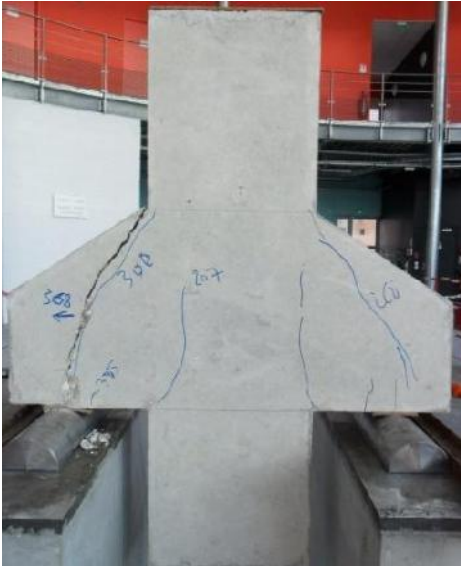
The results, as shows in Figure 8(a), 8(b), 8(c) and 8(d), distinguished mainly three types of failure: flexion failure, shear and fabrics peeling off and compression failure. Although, CI2b and C0 were the same rupture, noted that cracking

a) C0 : Flexion failure

There are mainly three types of strengthened reinforced concrete corbel failures: flexion failure, shear and fabrics peeling off failure, compression failure with two diagonal cracks, figure 8.

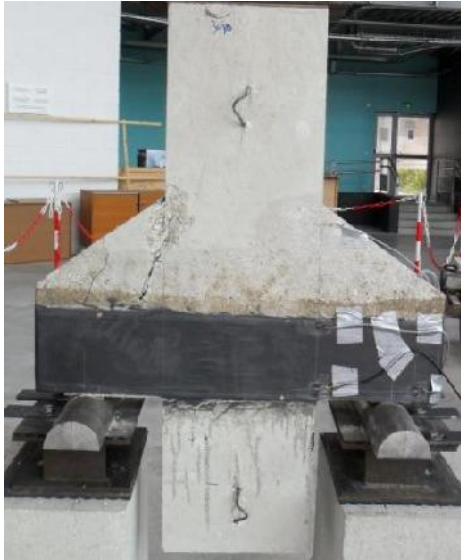
b) CB3u : Compression failure

concrete corbel without strengthening. The results show that curves are similar and ultimate load increases with a third reduction of deformation. The failure and crack patterns of the group strengthening with externally bonded one horizontal strip of fabric. In all four cases, first micro cracks is started at approximately the same load between 130 and 140 kN. There is one main diagonal shear crack almost at an angle 45 degrees and this crack is started at the bearing plate. This crack caused failure of the corbel. Corbel failed at ultimate loads at 651 kN.

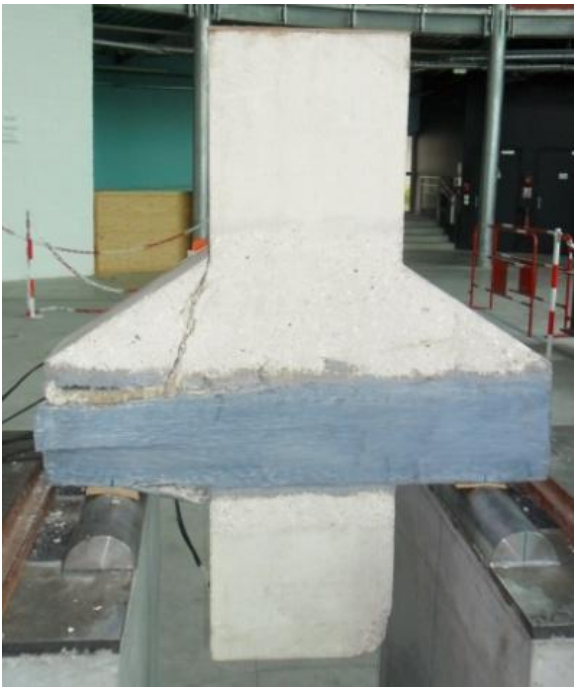
c) CP3u : Shear collapse with fabrics peeling off

This specimen was strengthened with externally bonded three horizontal fabric strip. There is only one major diagonal crack started at the bearing plate, and propagated towards the junction of the column and face of the corbel. This crack appears at a load of 310 kN and causes failure of the corbel. The corbel failed at an ultimate load of 380 kN. When the number of fabric strips is increased, the ultimate deformation of the corbel is caused by peeling off the strips of cloth. The accumulation of several strips of fabric on top of each other results in a thickening of the layer as a whole, and therefore, they peel off easily and cannot reach to the maximum load-bearing capacity of the composite. There was no apparent damage to the fabric, just concrete cracked major diagonal shear crack beneath the fabric. The concrete crack caused of debonded fabrics on the front and rear face of the corbel.

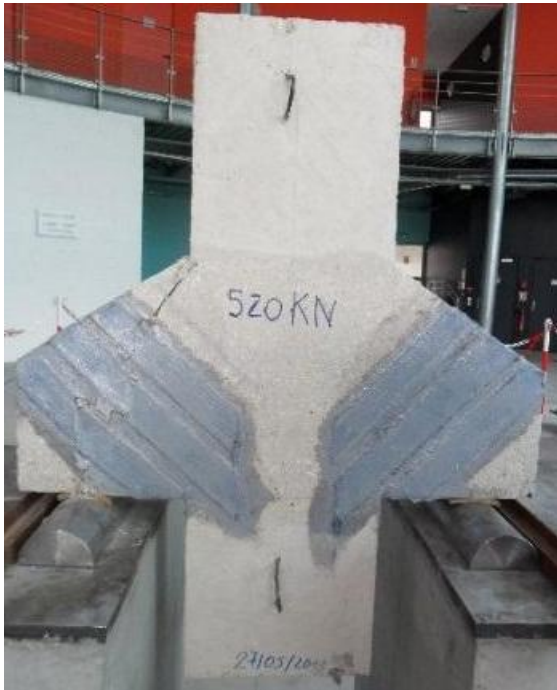
d) CI2b : Flexion and little compression failure

was different with appearance of a slight compression in C12b.

First flexural cracks appear at 116 kN. As with the above specimen CP3u, there is only one major diagonal crack started at the bearing plate, and propagated towards the junction of the column and face of the corbel. This crack appears at a load of 380 kN and causes failure of the corbel. The corbel failed at an ultimate load of 520 kN. There was no apparent damage to the fabric, just concrete cracked major diagonal shear crack. The collapse of CI2b is appeared by Shear failure diagonal crack of CFRP fabric.
