# Corrosion Mitigation of Steel Rebars Using Galvanic Anode Materials for Salt-deteriorated RC Slabs in Snowy Regions

**Index Terms**—anti-freezing agent, reinforced concrete deck slab, sacrificial anode, corrosion mitigation, salt damage

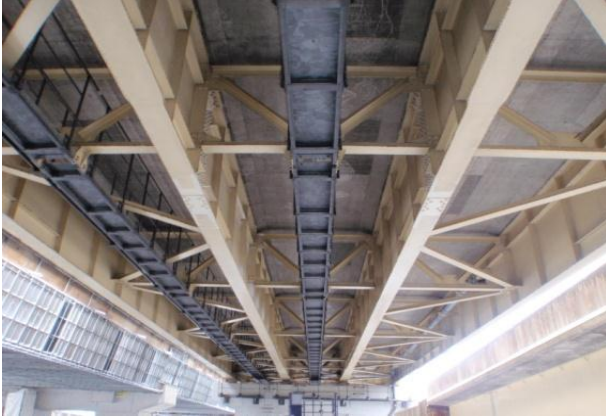
Figure 2. Condition of the target structure

Located in the Hokuriku district, the objective bridge of this study is a part of the elevated line of a highway. As can be seen in Fig. 2, the bridge is a composite bridge with a slab thickness of 220 mm and four main steel girders. Forty years have passed since the bridge was started in 1978 as a part of the important route which has a volume of traffic of 27000 vehicles per day and connects the East and West sides of the Kanazawa city.

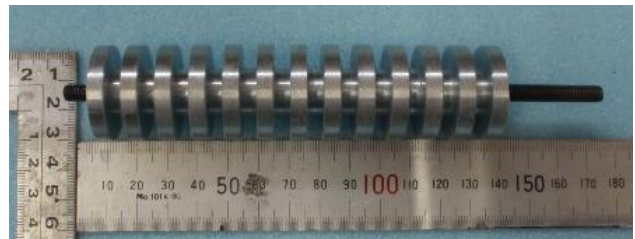
Figure 8. Galvanic anode material

Place the anchor at the deepest part of the drilled hole, and fix the anode material (see Fig. 8) to the anchor. When non-stick-type backfill material is used, as shown in Fig. 9, bentonite is previously attached to the galvanic anode material and then the anode is inserted into the hole. On the other hand, when the mortar type is used, mortar is injected after the packing installation as shown in Figs. 10 and 11.

After the installation work, the anode was connected with a wire and was then separately connected with a wire connected to the reinforcing bar of the slab.

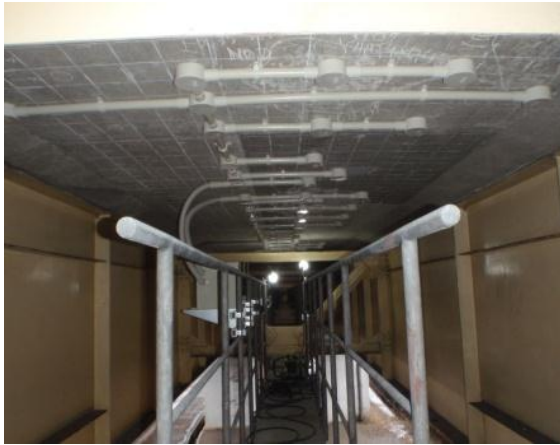
Figure 14. The proposed corrosion mitigation system

After the sensor installation, the electric wires used to connect the galvanic anodes are installed, then they are set into the protective conduit system. Moreover, the exposed parts of the anodes are also protected by protective boxes. Finally, the electric wires, the galvanic anodes, and the TW sensors are connected to a control box. The proposed sacrificial anode system after the installation work is shown in Fig. 14.

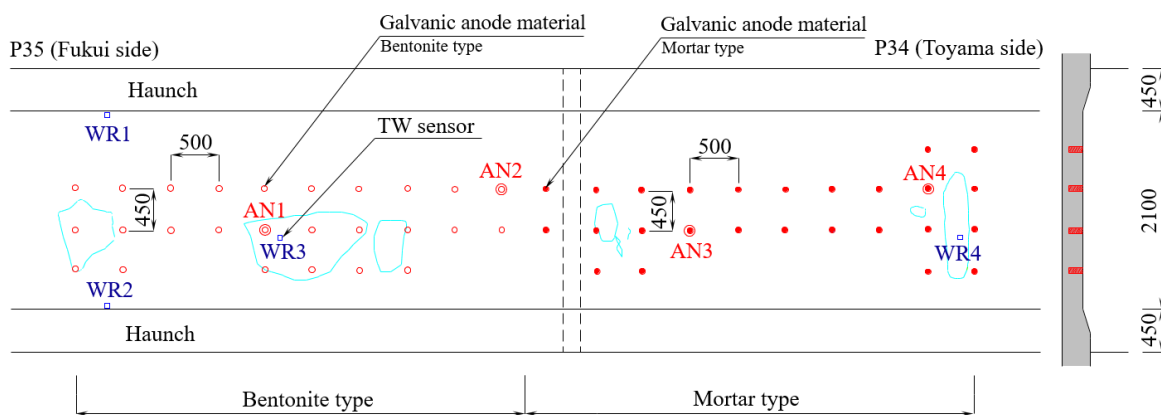
Figure 15. Installation positions of galvanic anode material and TW sensor (unit: mm)

The installation interval of the sacrificial anode material is influenced by the amount of reinforcing bar, the degree of corrosion of rebar, and resistance of concrete. Indeed, the applicability of the sacrificial anode material to the slab has been gradually investigated by indoor experiments with small specimens [19], exposure tests with large specimens [33], and verification tests with removed floor slabs [20]. From the previous results, the installation interval of the anode capable of securing the depolarization amount of about 50 mV, which is a measure of the steel corrosion mitigation in this study, was approximately 400 mm. In this test work, considering the spacing of the rebars, the installation interval of the anodes was selected as ~500 mm in the direction of the bridge axis and as ~450 mm in the direction perpendicular to the bridge axis. As an advantage of the repairing method using the sacrificial anode material, there is no need to install the anodes on the entire surface of the deck, and it is only necessary to install them on the deteriorated part and its surroundings. From the viewpoint of the above-mentioned advantages, only the white precipitate generation areas shown Fig. 3 and its surroundings require the anode system. However, the galvanic anodes were also installed at the healthy section in this study. The installation positions are shown in Fig. 15.

In order to evaluate the performance of the proposed method, the potential of the rebar was measured using the TW sensors and the portable reference electrode. Fig. 15 shows the measurement positions. Specifically, the TW sensors WR1 and WR2 measured the potential of the reinforcing bar in a sound place observed on the lower surface of the deck, while the potentials from areas with white precipitate were extracted from the measurement data of the sensors WR3 and WR4. In addition, the amount of current generated by the galvanic anode materials AN1 ~ AN4 was also analyzed to verify the effects of the variation in ambient temperature, the type of backfill materials and the severity of salt damage on the measured data.

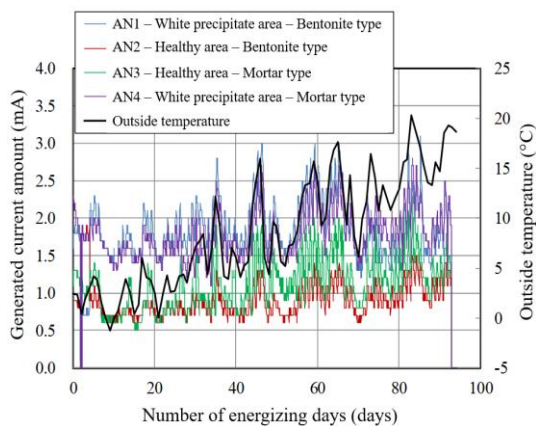
Figure 16. Variation in the amount of current generated by the galvanic anode material

Fig. 16 shows the variation in the amount of current generated by the galvanic anode material over time. In particular, the amount of electric currents generated by the anode materials installed at the areas with white precipitates (AN1 and AN4 positions) tended to be larger than those obtained from the sound places (AN2 and AN3 positions), and both tended to increase and decrease repeatedly with the change of the ambient temperature.

This is a characteristic of the sacrificial anode material that generates a large protective current for suppressing the high corrosion rate.

Although a comparison was also conducted on the two kinds of backfill materials, the outcomes showed that there was no apparent difference in the amount of current generated by the galvanic anode materials utilizing the mortar-type or bentonite-type backfill materials, as shown in Fig. 16. Specifically, there was a marginal difference in the amount of current obtained from the areas with white precipitates (AN1 and AN4 positions). Regarding the anode material installed at the sound areas, the amount of current produced by the anode using the mortar type (AN3 position) was relatively higher than that of the bentonite type (AN2 position).
