# A Numerical Investigation on the Collapse of the Champlain Towers South in Florida

**Abstract**—In this study, the Champlain Towers South building collapse in Florida allegedly caused by a deck collapse was examined through the finite element analysis based on the existing hypotheses and investigation. The Adaptively Shifted Integration (ASI) – Gauss code was applied for the numerical analysis. In addition, the member strength failure algorithm of RC components was modified, and the flat-plate structure was introduced into the numerical model of the building. According to the analyses, the building did not collapse when the pool deck beams connecting to the columns of the 1st-floor interior, so-called key columns, were removed by the collapse of the pool deck. When the model was revised to include deterioration of concrete slab and corrosion of rebars, and then triggered by the removal of columns in the underground parking garage, the middle section of the buildings reached a total collapse. This supports the latest collapse theories, which cite punching shear failure at pool deck columns as the initiating event.

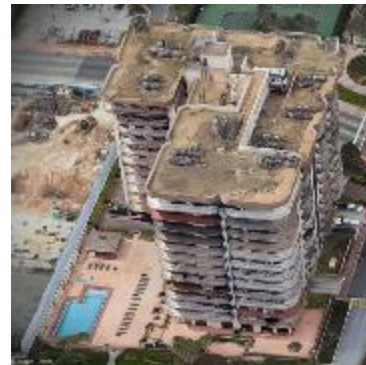
Fig. 1. Champlain Towers South Condominium.

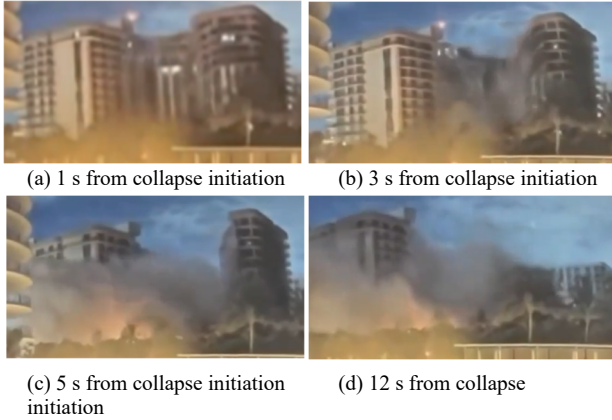
The middle and eastern sections of Champlain Towers South in Florida (Fig. 1), USA, a 13-story condominium built in 1981, collapsed without warning at approximately 1:25 a.m. on June 24, 2021. According to the surveillance video [1], the collapses of the middle section and the following eastern section only lasted for 12 seconds (Fig. 2). At least half of the 136 units in the building had collapsed (Fig. 3), and all of them were characterized by the fact that they collapsed instantly after it began to collapse. The U.S. National Institute of Standards and Technology (NIST) investigated the collapse the following day, June 25, and a total of 98 deaths were confirmed as of July 22, 2021 [2]. It is currently believed by many that the direct cause was the additional concrete, sand, and pavers placed on the surface layer of the pool deck located in the southeast area of the building in 1996. This increased its weight, causing the deck to finally cave in as punching shear gradually progressed between it and the columns in the basement [3]. The collapse of the deck reduced the

Fig. 2. Collapse sequence of the Champlain Towers South [1].

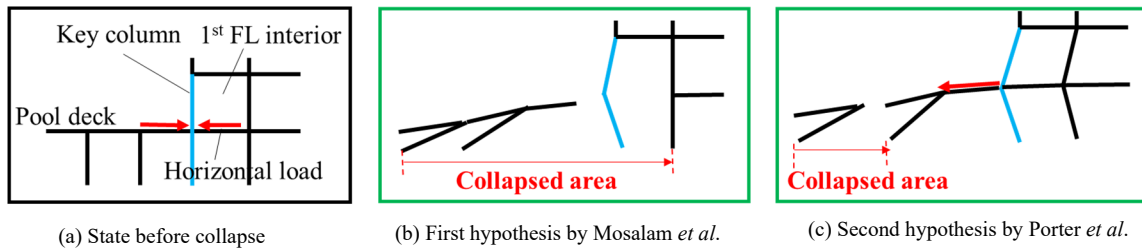
Fig. 4. Hypotheses of the building collapse.

Two hypotheses presented in the Washington Post [6] suggests that the collapse of the pool deck into the underground parking garage may have weakened the key columns and caused the widespread collapse. The light blue member shown in Fig. 4(a) is a key column that is critical to the support of the building. The red arrows in the figure indicate the horizontal loads acting on the column. The left side of the key column represents the pool deck connected to the building, and the right side represents the 1st-floor interior. An illustration explaining the first hypothesis by Mosalam *et al.* is shown in Fig. 4(b). It states that the collapse of the pool deck extended beyond the key columns, causing the columns to buckle due to overloading caused by the loss of horizontal support on the deck side. In this study, we call this Hypothesis 1. An illustration explaining the second hypothesis by Porter *et al.* is shown in Fig. 4(c). It states that the collapse of the pool deck was not so extensive that the key columns were pulled by the surrounding deck beams, causing the key columns to collapse together with the pool deck beams. We call this Hypothesis 2.

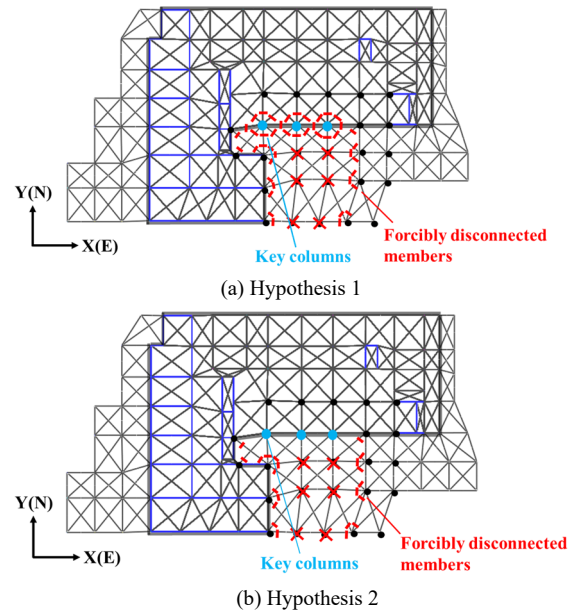
To reproduce the conditions in Hypothesis 1, the pool deck collapse was simulated by forcibly disconnecting the members connected to the east, west, and north sides, the members between the key columns, the deck columns, and the floor members inside the building as shown in Fig. 7(a). As for Hypothesis 2, the pool deck collapse was simulated by forcibly disconnecting the members connected to the east and west sides and the deck columns, as shown in Fig. 7(b). The time increment was set to 1 ms, and a total of 3000 steps were computed.

Fig. 7. Numerical conditions based on Hypotheses 1 and 2 [6].

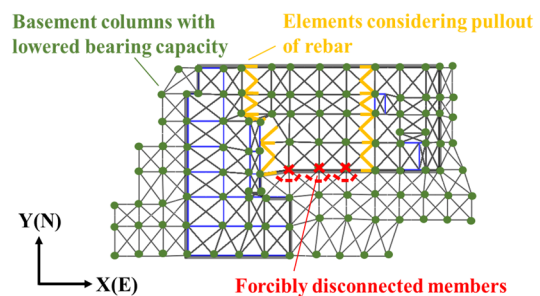
Since the rebar at both ends of the floor can be seen to be almost cleanly pulled out as shown in Figs. 10 and 11, the critical value of shear strain of the flat-plate floor members from the ground to the 13th floor, shown in yellow in Fig. 14, was set to 1/1000 to account for the pullout of the rebar at the joint between the wind-resistant wall and the flat-plate floor. The weakening of the concrete and reinforcing bars in the subterranean columns was also considered based on the nearly vertical drop of the middle building seen in Fig. 2. According to Sanchez *et al.* [20], after a certain degree of concrete deterioration, the compressive strength reduces about 35% and the modulus of elasticity about 70% at maximum. Therefore, the compressive strength and modulus of elasticity of the concrete in the basement columns were set to 65% and 30% of their original values, respectively, to follow a worst-case scenario. In addition, the tensile yield stress of the steel bars and shear rebars was set to 1/200 of their original values to account for the deterioration of the rebars and poor workmanship. The columns shown in green in Fig. 14 are the columns with lowered bearing capacity. In the analysis, the damage to the subterranean columns caused

Fig. 14. Numerical conditions based on the hypothesis with deterioration of concrete slabs, corrosion of rebars, and loss of key columns as the main cause.

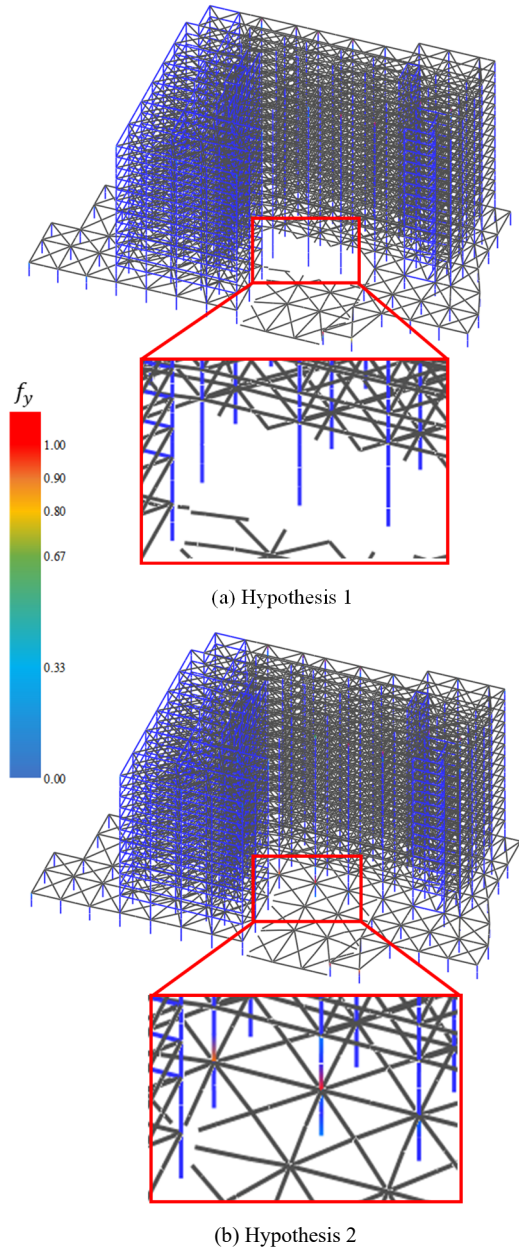
Fig. 15. Numerical results based on the hypotheses with pool deck collapse as the main cause.

When the extent of pool deck failure exceeded the key columns as in Hypothesis 1, the key columns did not

buckle and did not lead to a final collapse state (Fig.15(a)). In the case where the extent of pool deck failure did not exceed the key column as in Hypothesis 2, the key column lead to a final collapse state, but the entire building did not collapse (Fig. 15(b)). These results suggest that other factors may have triggered the collapse of the building. It should be noted here, again, that the analyses for Hypotheses 1 and 2 did not consider the failure of the connection joints between the pool deck beams and the 1st-floor columns, and there is still room for consideration.

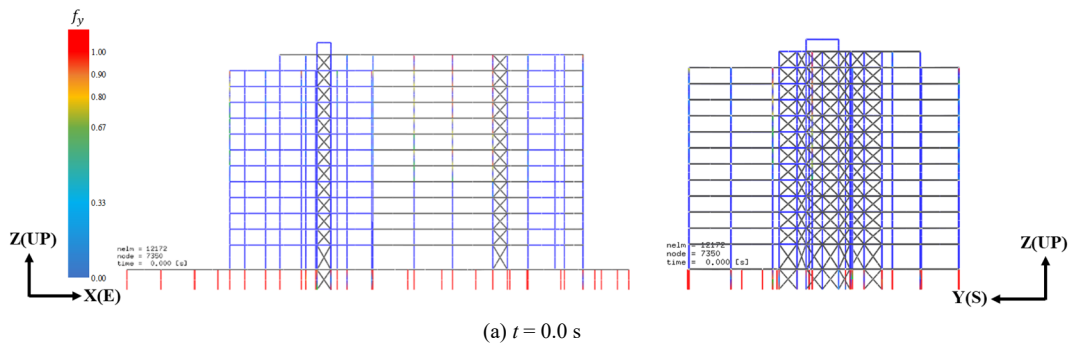
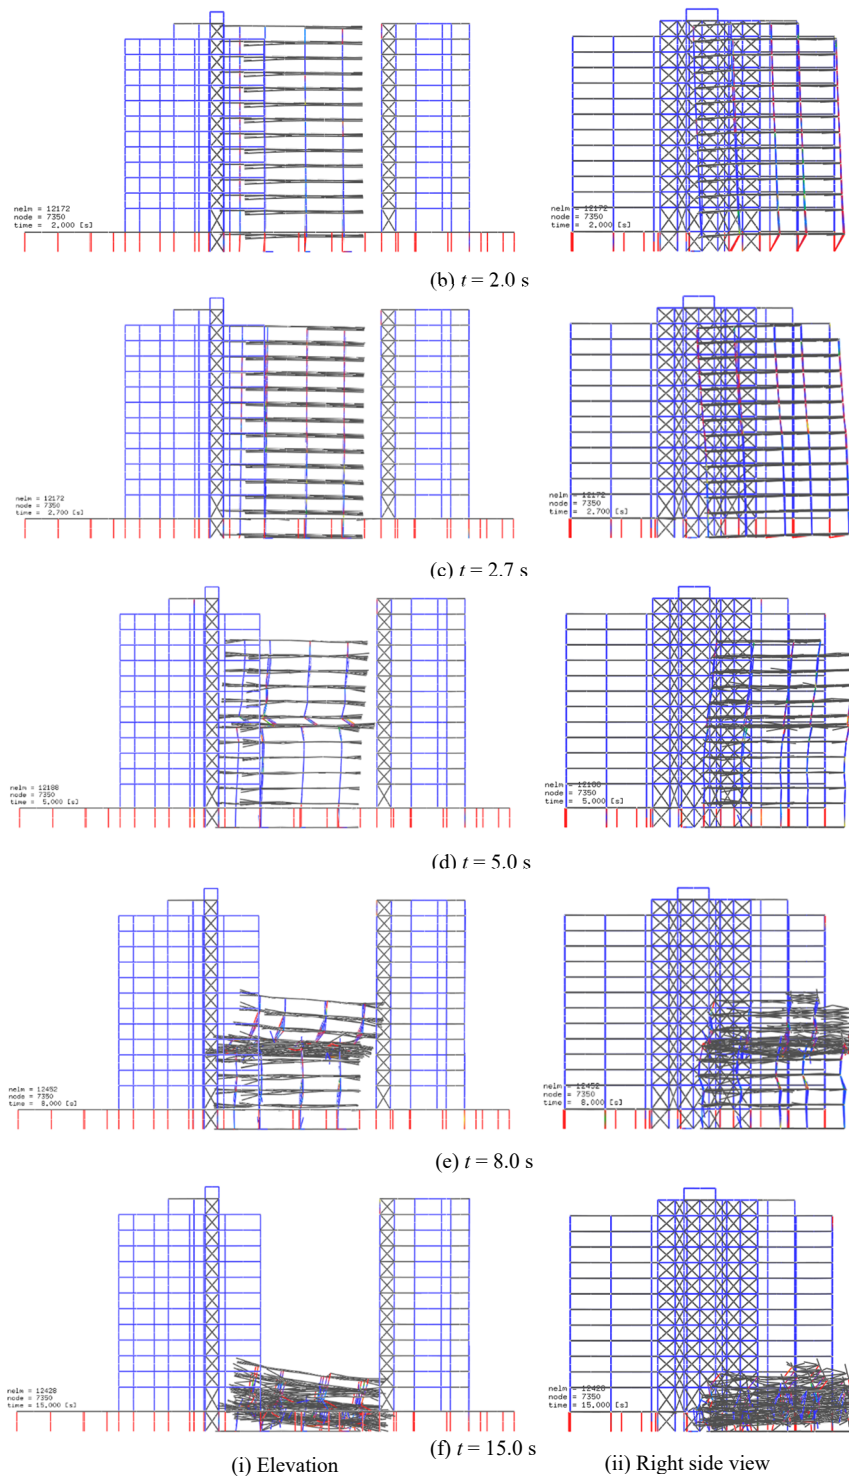
Fig. 16 shows the collapse process of the model considering the reduction in bearing capacity of the reinforced concrete, the pullout of the rebar, and the loss of key columns at the start of the analysis ( $t = 0.0$  s). As shown in Fig. 16(a), when the reduction in bearing capacity of the basement columns was considered, the columns were in the final state from the beginning; they are shown in red in the figure. The key column and floor members were fractured at  $t = 0.005$  s. Subsequently, the joints at both ends of the middle section began to fracture under their weight, and the middle section of the building fell. Then, at  $t = 2.0$  s, all the joints at both ends are fractured, as shown in Fig. 16(b). The remaining subterranean columns could no longer withstand the vertical load and the building tilted to the north. The subterranean columns are completely grounded to the floor, as shown in Fig. 16(c), at  $t = 2.7$  s. 5.0 s after the start of the analysis, as shown in Fig. 16(d), the columns in the 7th to 8th floors collapsed in the East-West direction and fell on top of the 6th floor. Then, at  $t = 8.0$  s, the columns in the 6th to 9th floors collapsed and the floors piled up, as shown in Fig. 16(e). The 5th to 7th floors in the eastern section were in contact with the 11th to 13th floors in the middle section and were vibrating slightly. After 15.0 s from the start of the analysis, only the middle section collapsed completely, as shown in Fig. 16(f), and the eastern section did not collapse. Fig. 17 shows an isometric view of the numerical result at  $t = 15.0$  s.

Fig. 16. Numerical results based on the hypothesis with deterioration of concrete slabs, corrosion of rebars, and loss of key columns as the main cause.

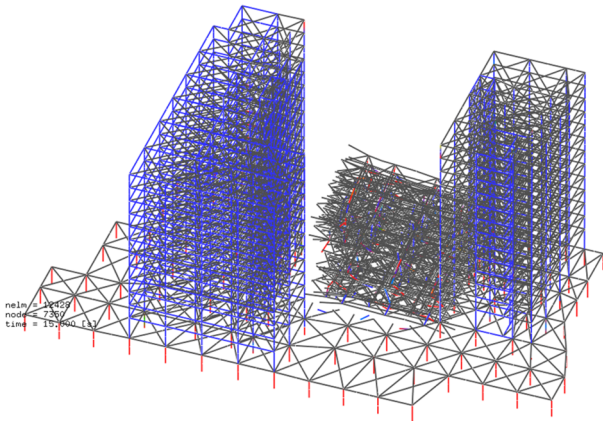
Fig. 17. An isometric view of the numerical result at  $t = 15.0$  s.
