Experimental Study of the Evolution of the Breach and the Discharge through the Breach Resulting from Piping Due to Seepage at the Mid-part of Earthfill Dam

M. Sukru Guney¹, Emre Dumlu^{2*}, and Merve Okan¹

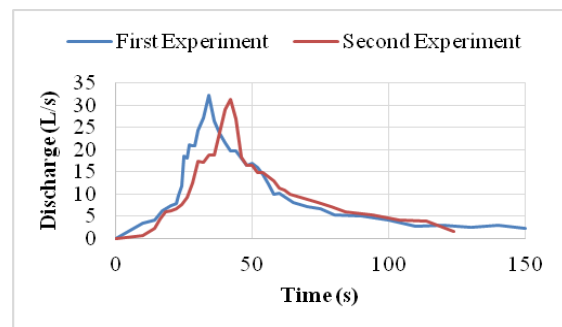
Figure 14. Time-varied discharges through the breach.

The discharge of water through the breach was determined by using the continuity equation.

$$\Delta S = (Q_{\text{pump}} - Q_{\text{breach}}) \cdot \Delta t \quad (1)$$

where Q_{pump} is the flow rate delivered by the pump, Q_{breach} is the discharge through the breach, ΔS is the storage change in the channel during the time interval Δt . The average velocity V of the flow through the breach was approximately calculated by using the Eq. (2).

The temporal water depths in the channel and discharge through the breach calculated by Eq. (1) are given in Fig. 13 and Fig. 14, respectively.

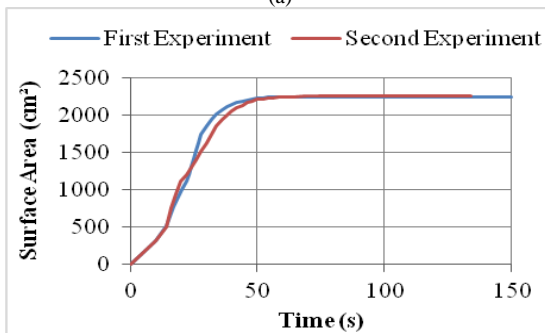
Figure 15. Temporal variations of the breach area (a) at upstream and (b) at downstream.

The temporal variations of the breach area at upstream and downstream are shown in the Fig. 15.
