Fire Fighting Strategies for Light Steel Structure Buildings (Metal Houses)

Index Terms—light steel structure, metal houses, fire resistance performance, fire loading, fire fighting strategies

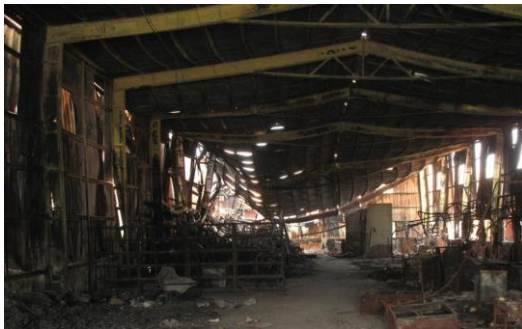
Figure 1. Mountain-shaped structural system of metal houses.

Presently, most metal houses in Taiwan have no more than two floors, and their structure is mostly a mountain shaped structure made with steel columns and beams as shown in Fig. 1. Some metal houses also have an intermediate layer room as shown in Fig. 2. When the house is on fire, the steel structural members will undergo heat-induced deformation as shown in Fig. 3, causing the center of gravity of the entire building structure to shift. This condition generates a great pulling force that acts on the joints of the steel beams and columns of the roof and puts more force on the bolts of these joints. If these heated bolts are rapidly cooled down by water sprayed to extinguish the fire, the ductility of these bolts drops quickly, and when the force exceeds what the bolts can tolerate, the bolts will break, and the pulling force originally acting on the broken bolts will now act on the remaining bolts. As more and more bolts are broken, the force acting on the remaining bolts will be greater, and more bolts will be broken. Eventually, there will be a point when all joints connecting steel columns and beams are broken, and the roof will collapse. This is the situation, i.e., broken bolts at joints, found by the study from examining numerous metal house fire scenes. See the dotted circle in Fig. 4.

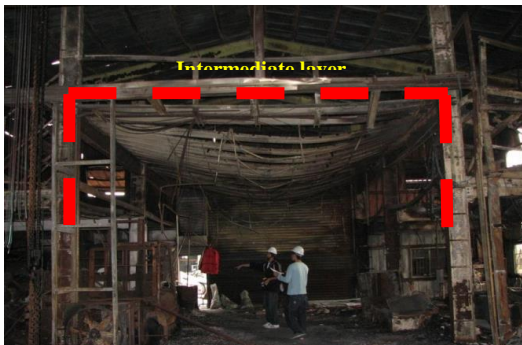
Figure 2. Structural frame system of metal house with an intermediate layer room.

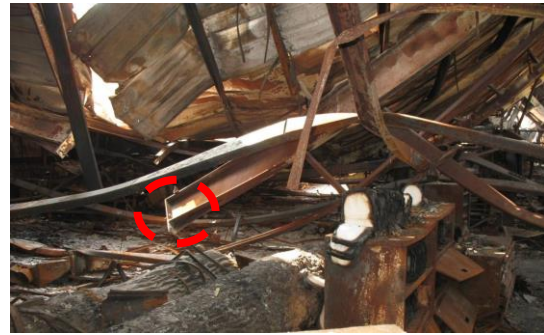
Figure 3. Mountain-shaped structural system of metal houses.
