# Application of Hirosawa Method to Compare Seismic Performance of Reinforced Concrete Buildings during the Earthquake of 2010 in Chile

**Abstract**—The Hirosawa Method is used by the Pan American Health Organization to evaluate the structural vulnerability of Health Facilities in Latin America and the Caribbean. In this study, this method has been addressed to evaluate the structural vulnerability of reinforced concrete buildings in Chile during the 2010 Earthquake. A sample of 116 buildings of medium height (between four and ten floor height) were analyzed to compare their real behaviour during the earthquake with the seismic performance given by the Modified Hirosawa Method, in order to determinate if this method can be used to evaluate the structural vulnerability of these type of structures in Chile. According to the results of this investigation, the Hirosawa Method is useful to establish trends in seismic behavior for the analyzed buildings, since of the 26 buildings defined with a safe performance against a seismic event by the Hirosawa Method, only one suffered severe damage and none suffered serious damage during the 2010 Earthquake.

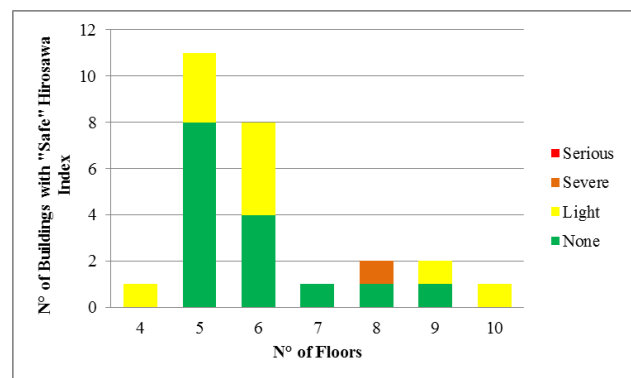
Figure 3. Buildings with “Safe” Performance in relation with their real damage and number of floors

Moreover, when compared the floor distribution for buildings with “safe” performance, as illustrated in Fig. 3, it can be seen that the results from the Hirosawa Method are generally consistent with their real damage during the earthquake. For buildings up to seven floor height all the analyzed buildings had none or light damage during the earthquake. On the other hand, when the results from the Hirosawa Method are compared with real performance of buildings of eight to ten floors height, it can be seen that the methodology is less accurate when real behaviour of the building is compared with their catalogued performance, as more damaged buildings appear with a catalogued “safe” performance.

As can be seen also from Fig. 6, a high percentage (78%) of the buildings with five floors had an index of seismic behaviour under 0.55, and a 61% of buildings with six floors have also an “insecure” performance. And when these low index are compared with real performance, it can be seen from Fig. 3 and 5 that a high percentage of the analyzed buildings with five and six floors had some damage (light or severe), which is consistent with a lower  $I_s$  index.

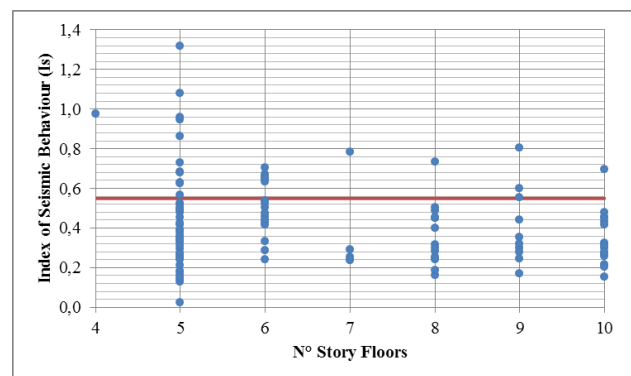
Figure 8. Relation between the Number of floor floors and the index of Seismic Behaviour ( $I_s$ ) of each building.

Particularly, Fig. 8 presents the Index of Seismic Behaviour ( $I_s$ ) distribution in buildings with different storey floors. The red line represents the index of Seismic Judgment ( $I_{s0}$ ), which is equal to 0.55 to all cases, as can be seen in Table III. All points lower this line are considered low by the methodology, thus leading to an “insecure” performance. As can be seen, the majority of the analyzed buildings had five floors, and their index is rather low compared with the index of seismic judgment.

Likewise Fig. 6 and 8 illustrated a high percentage of low  $I_s$  index for buildings with more than six floors height, with percentages of 80%, 93%, 70% and 93% for buildings with seven, eight, nine and ten floors respectively. And compared with the results shown in Fig. 5, it can be seen that a high percentage of these buildings suffered some damage during the earthquake.
